SUBJECT: A Floorhand Dies When He Falls Off a Mobile Oil Well Servicing Rig

SUMMARY
California FACE Report #14CA001

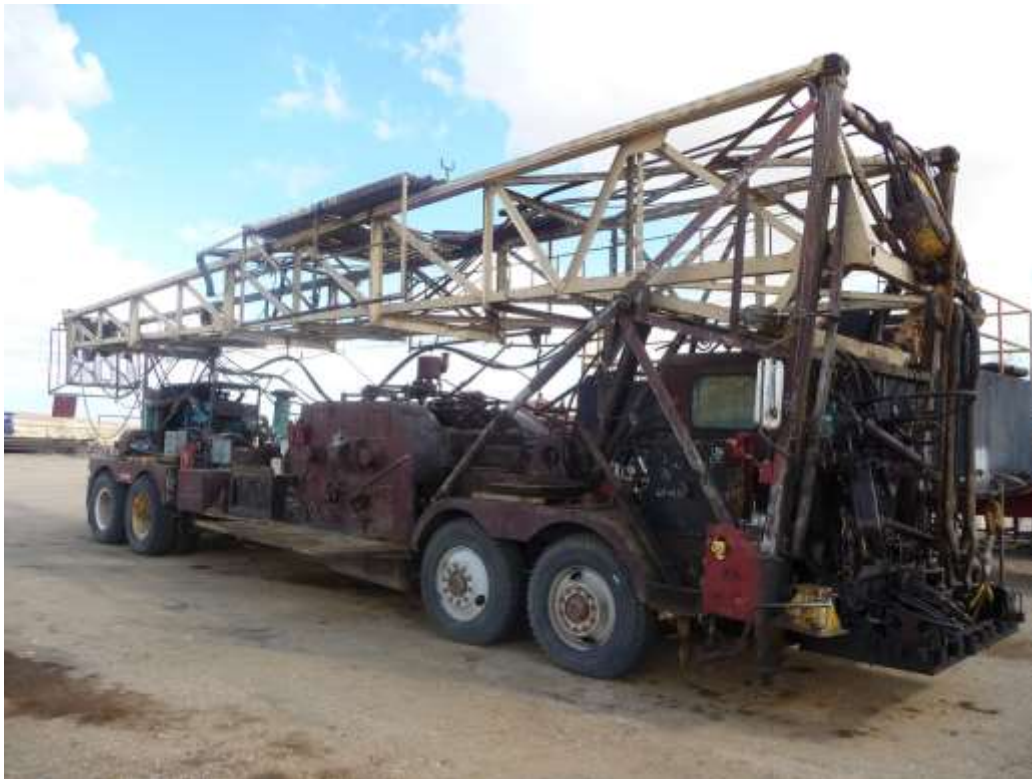
Exhibit 1. The mobile oil well servicing rig involved in the incident.

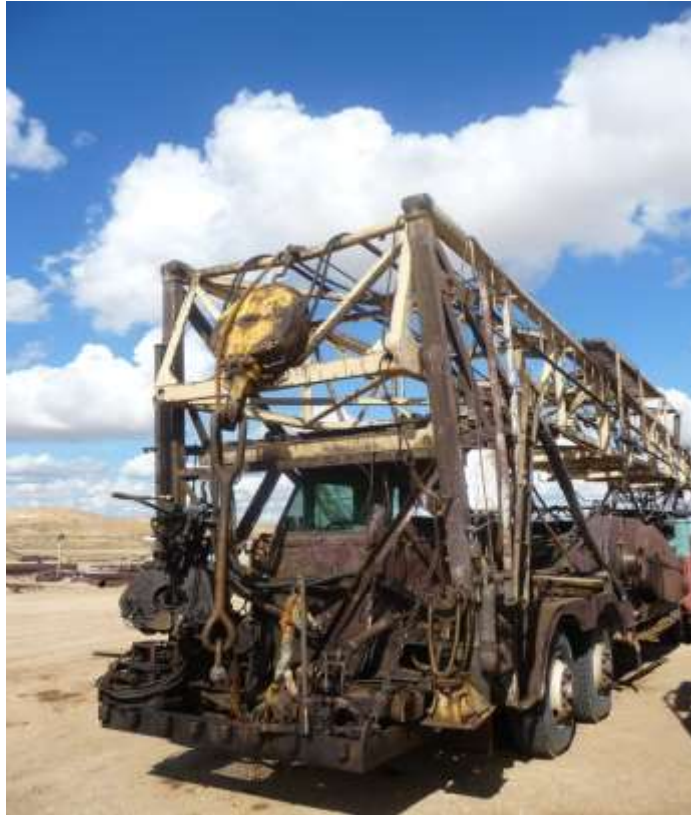
Exhibit 2. The front of the rig involved in this incident.

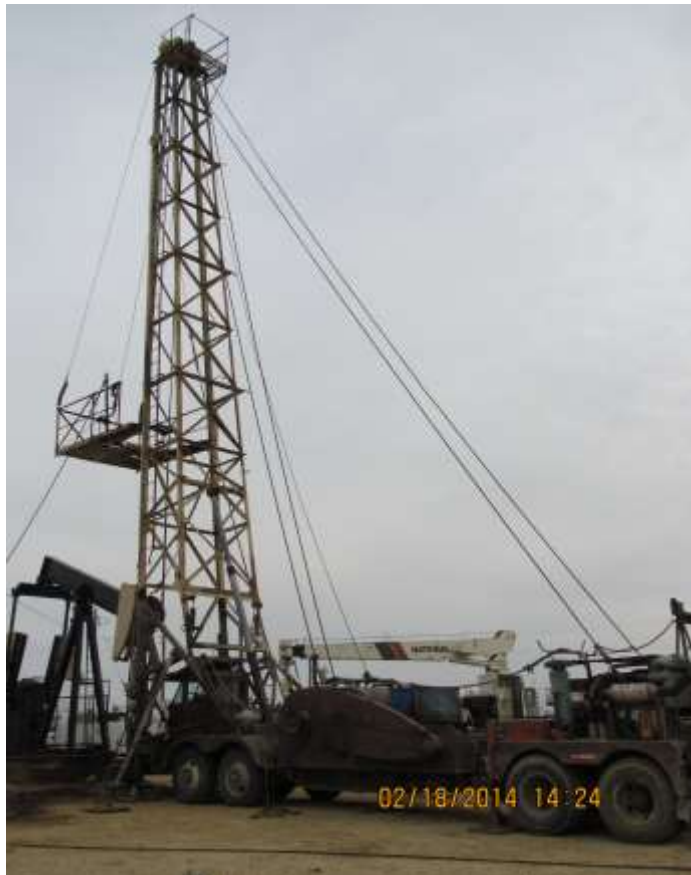
Exhibit 3. The rig at the incident scene with the boom extended.

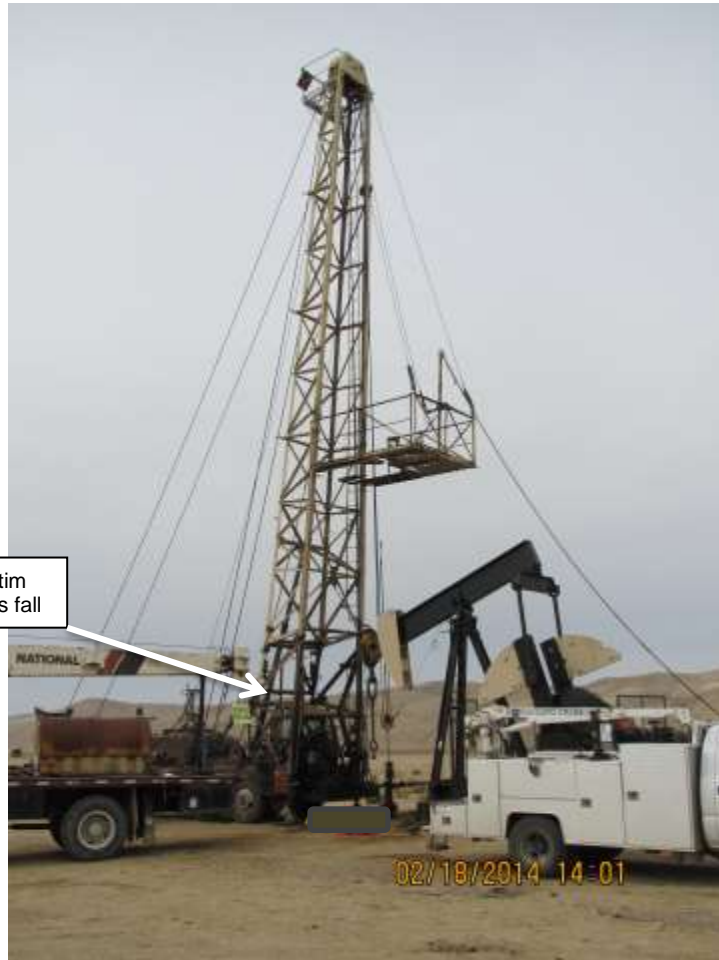
Discussion: In this incident, the victim was standing on the deck of the cab, approximately eight feet above ground level, and did not attach his personal fall restraint system. A fall from more than six feet can result in severe injury including fracture, internal bleeding, and possible death from spinal injury. The California Petroleum Safety Orders require that a safety belt and lanyard be used as a restraining system for each employee working on a derrick or mast at a height more than ten feet (10') above the derrick, mast floor, or ground level. Federal OSHA requires fall protection for any height greater than six feet for most industries. Severe injury can occur if an employee falls from a height of greater than six feet. This system consists of anchorages, connectors, and a body belt or full body harness. Had the victim in this incident attached his personal fall restraint system to an anchor point, the fall may have been prevented.

Location where the victim was working prior to his fall

Exhibit 4. The location where the victim fell from.

Recommendation #2: Mobile oil well servicing rigs are equipped with fall restraint tie-off points at employee working positions.

Discussion: In this incident, the victim was standing on a deck without guardrails, as this would interfere with the boom position during travel. As an older piece of equipment, the deck of this rig was not designed with tie-off points or anchors that allowed for a fall restraint system. Some newer mobile oil well servicing rigs are designed with features that can be used for this purpose. Alternatively, the deck could be retrofitted with anchor points. Although the victim and likely many other employees had worked off this deck many times in the past without incident, the risk of severe injury from a fall was nonetheless present. Had the employer ensured that this mobile rig had anchors for a fall restraint system, the victim may have tied off and prevented his fall.
