REPORT#: 21CA003

REPORT DATE: November 15, 2022

Farm Laborer Died When Struck by a Tomato Harvester — California

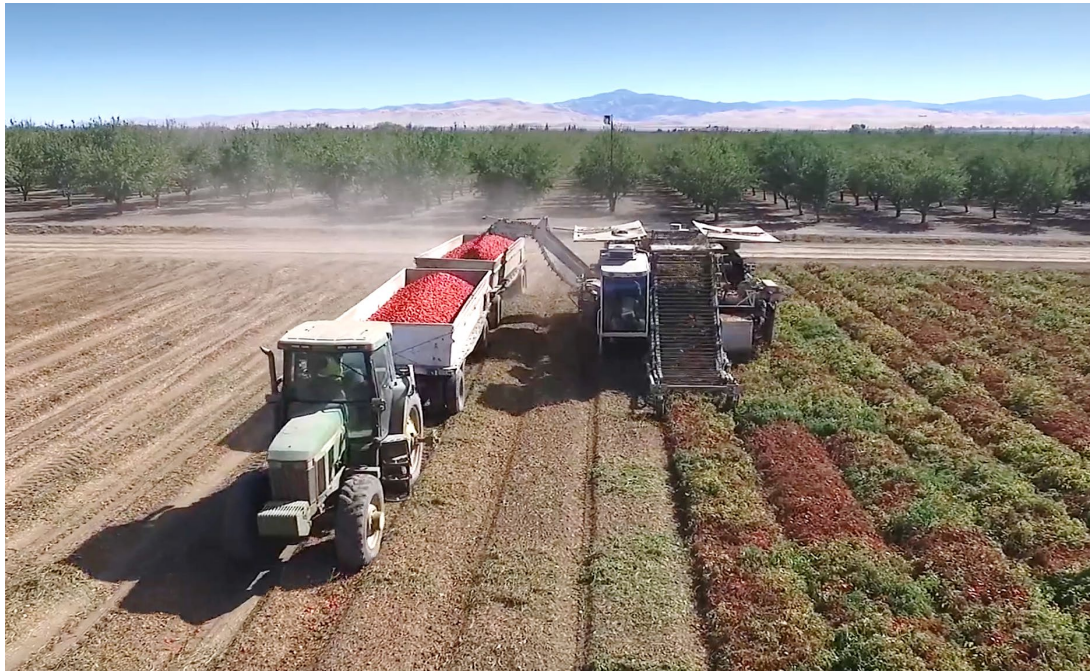
**Exhibit 2. A tomato harvester (on right) during the harvesting process.
Photo courtesy Westside Equipment.**

The primary piece of equipment involved with this incident was a Westside Equipment Company Commander tomato harvester (Exhibits 1-3). The tomato harvester was a tractor-based piece of agricultural equipment that was approximately 37 ft. long x 12 ft. wide x 11 ft. high and weighed about 32,000 pounds (16 tons). It operated by lifting and slicing tomato vines onto a conveyor that fed the tomatoes and vines through a series of blades, conveyers, shakers, and air pressure. The tomatoes were separated from the vines and crossed a worker-attended sorting station before being conveyed overhead to an open-top trailer pulled alongside the harvester by a tractor (Exhibit 2). The tomato plant vines and leaves, once separated from the fruit, were ejected as mulch from the rear of the harvester. The harvester was driven by an operator in an enclosed cab at the front of the machine. It had platforms on both sides where workers (known as sorters) stood to manually remove any residual debris, vines, or unripe/damaged tomatoes from the conveyor prior to the tomatoes being transferred to the trailer (Exhibit 4). During operation, the harvester was very noisy, making communication between the sorters and the operator difficult. It also could possibly generate a large amount of dust, depending on the conditions in the field at the time of harvesting.

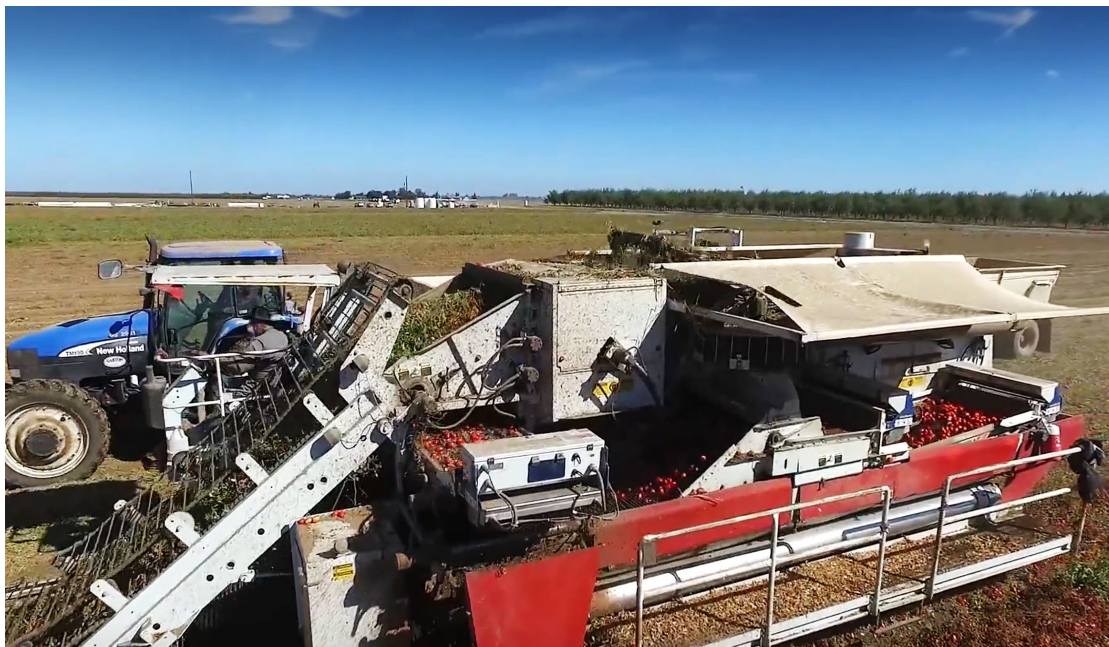
**Exhibit 3. Close-up of a tomato harvester during the harvesting process.
Photo courtesy Westside Equipment.**
