SUBJECT: A butcher died after getting his hand caught in a meat grinder.

SUMMARY
California FACE Report #03CA008

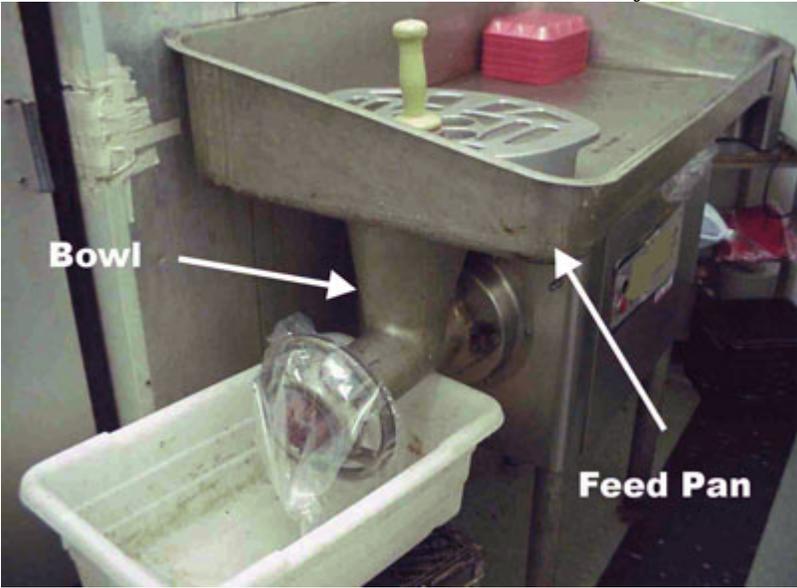
03CA008
Exhibit #2

A picture of the meat grinder’s motor that was involved in the incident.

Recommendation #1: Ensure users of meat grinders disconnect or lockout and tagout the power source before starting the cleaning process.
