SUBJECT: A youth dies when a forklift rolls over on him.

SUMMARY
California FACE Report # 04CA007

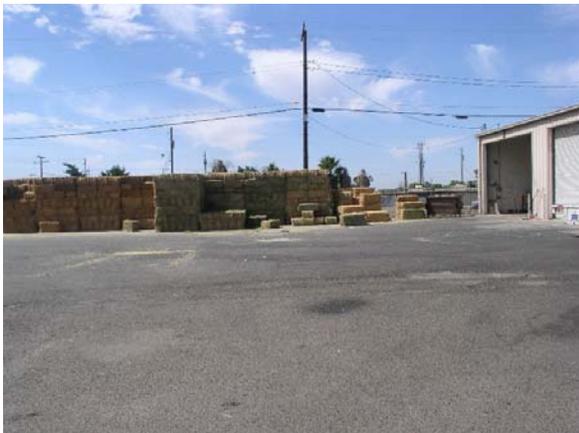
Exhibit 1. The site of the incident.

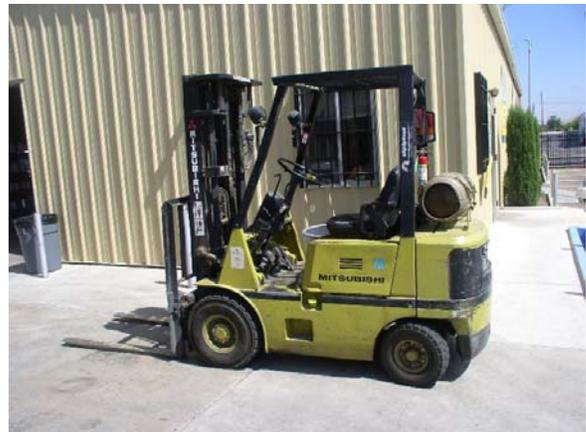
The site of the incident was a commercial grain and hay feed store with an asphalt paved yard. The machine involved in the incident was a propane-powered forklift (**Exhibit 2**). The victim's job title was a "bag hauler," and his duties consisted of placing the items a customer purchased in a bag and then carrying the bag to the customer's vehicle. The victim had graduated from high school, and was planning to work part-time, no more than three days per week, and no more than five hours per day.

Exhibit 2. The forklift involved in the incident.

- **Establishing a system to control access to power-driven machinery.** The store had an informal policy of leaving the forklift keys in the ignition during normal business hours. All the other employees and the store manager were certified to operate the forklift, so it was convenient to do this. Unfortunately, the victim was never told that he was not allowed or authorized to operate the forklift. Future situations like this might be avoided by placing power machinery keys in a secure, monitored location, or by establishing some other system to control access.

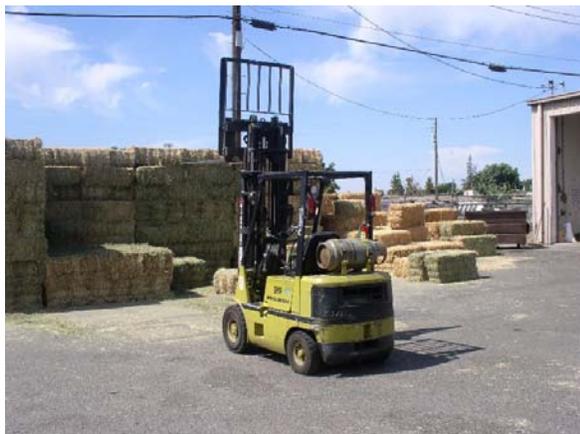
Exhibit 3. The forklift mast in the raised position.

The forklift was always parked on the side of the store with the keys in the ignition. The victim started the forklift and then drove to the other end of the yard where the hay was stacked. The hay bales were stacked seven bales high, so the victim raised the forklift mast and attempted to get the top bale. With the forklift mast raised high in the air, the victim backed the forklift over a rain gutter built into the asphalt yard. The victim lost control of the forklift and it overturned on its left side, pinning the victim as he attempted to jump free.

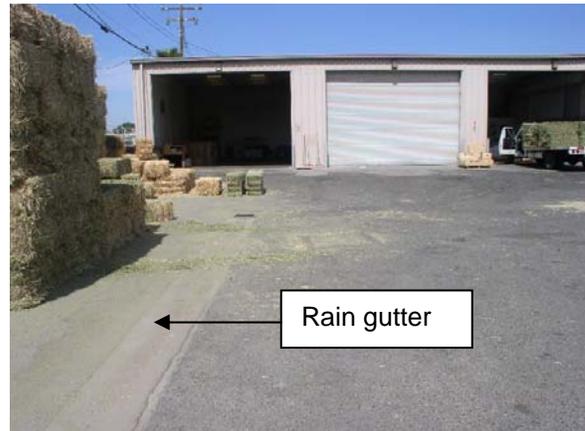
Exhibit 4. The rain gutter built into the asphalt yard.

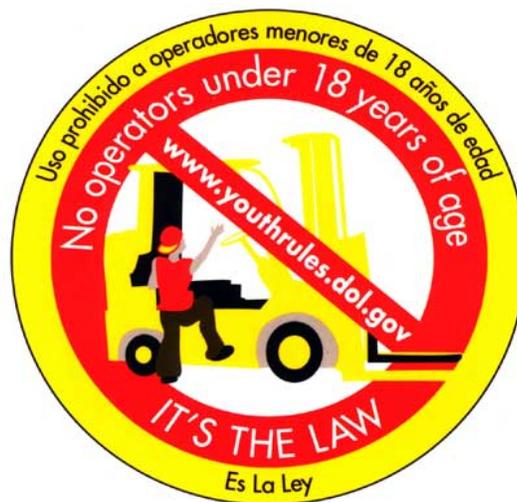
Exhibit 5. This sticker “NO OPERATORS UNDER 18 YEARS OF AGE. IT’S THE LAW,” is available from the local Wage and Hour office of the U.S. Department of Labor or from the DOL website <http://www.youthrules.dol.gov/posters.htm>

- **Identifying and labeling equipment that is not to be operated by workers younger than 18 years old.** Employers can obtain stickers in English and Spanish that indicate “**NO OPERATORS UNDER 18 YEARS OF AGE. IT’S THE LAW**” from the local Wage and Hour Office of the U.S. Department of Labor (DOL). These stickers can be downloaded from the Internet and should be affixed in a noticeable place on forklifts. A supervisor should be assigned to ensure, through periodic inspections, that only authorized and trained operators are operating forklifts.
