SUBJECT: Two Laborers Die from Hydrogen Sulfide Exposure in a Confined Space at an Organic Waste Recycling Facility

SUMMARY
California FACE Report #11CA008

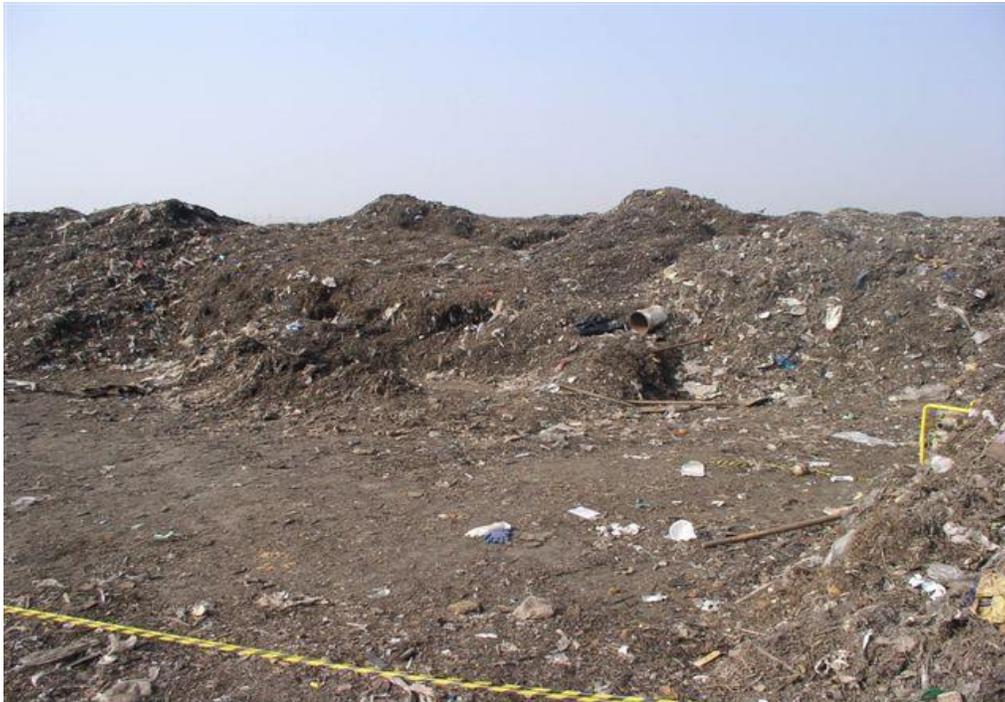
Exhibit 1. The incident scene.

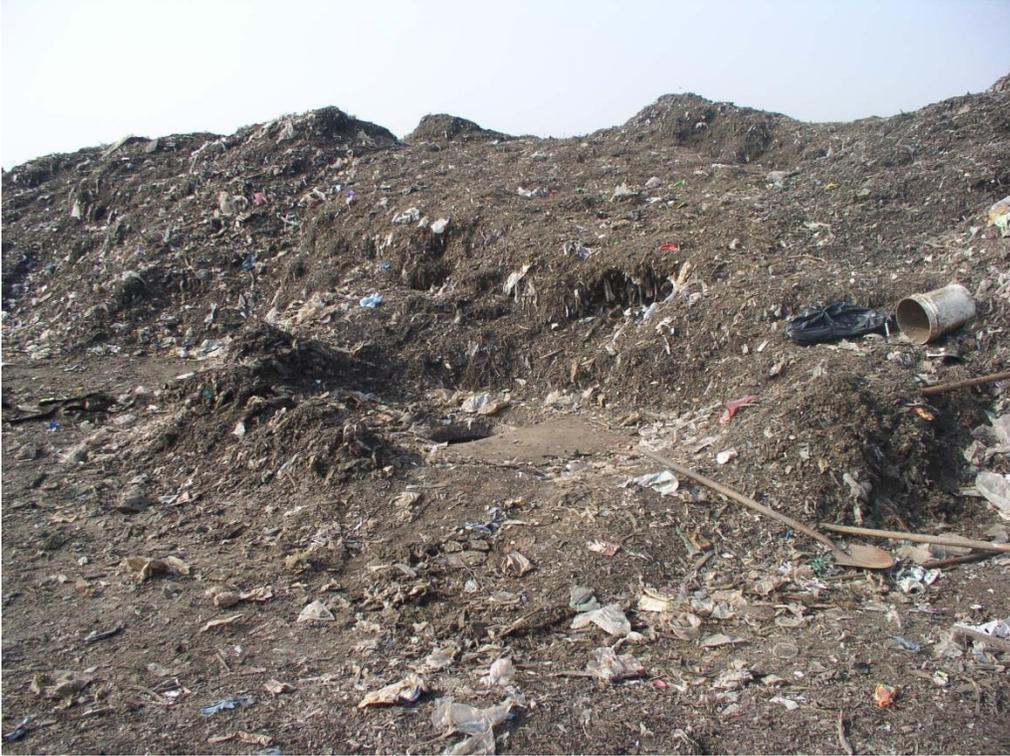
The drainage system consisted of 24-inch diameter drainage pipes strategically angled beneath the soil and 14 vertical shafts (manholes) ranging in depths of 4 to 10 feet and 36 inches in diameter. Each of the vertical drainage shafts was covered with a solid metal plate. The vertical shaft involved in this incident was 10 feet in depth, six feet in diameter at its base, and had three drainage pipes leading in and one pipe exiting toward the catch basin.

Exhibit 2. The shaft opening.

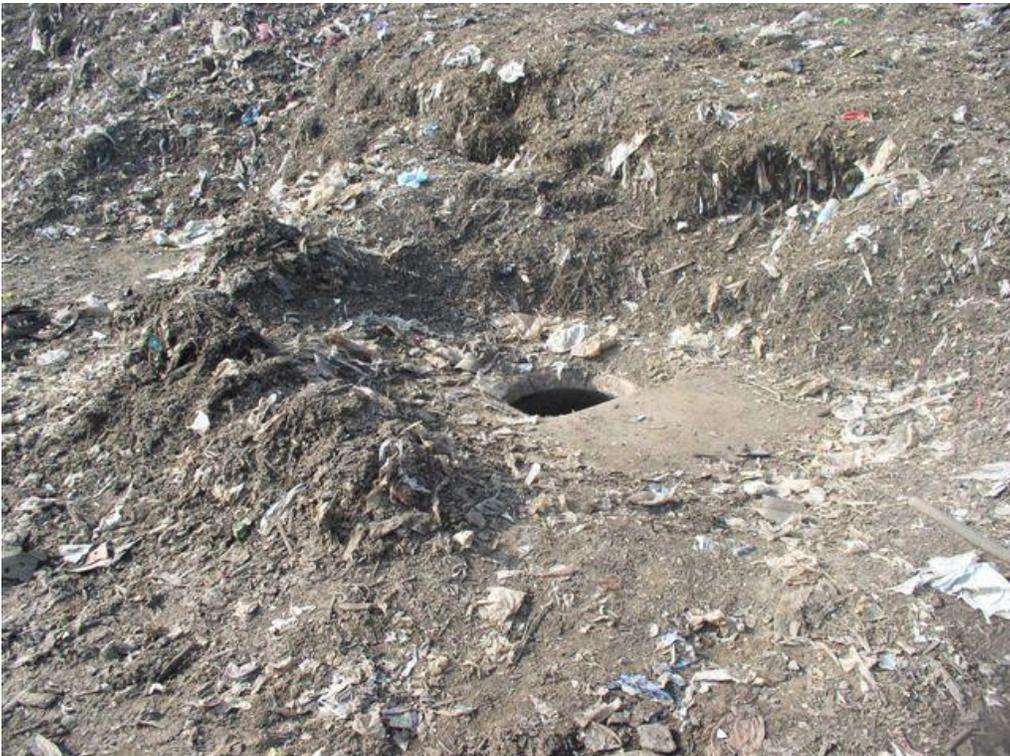
Exhibit 3. The shaft opening.

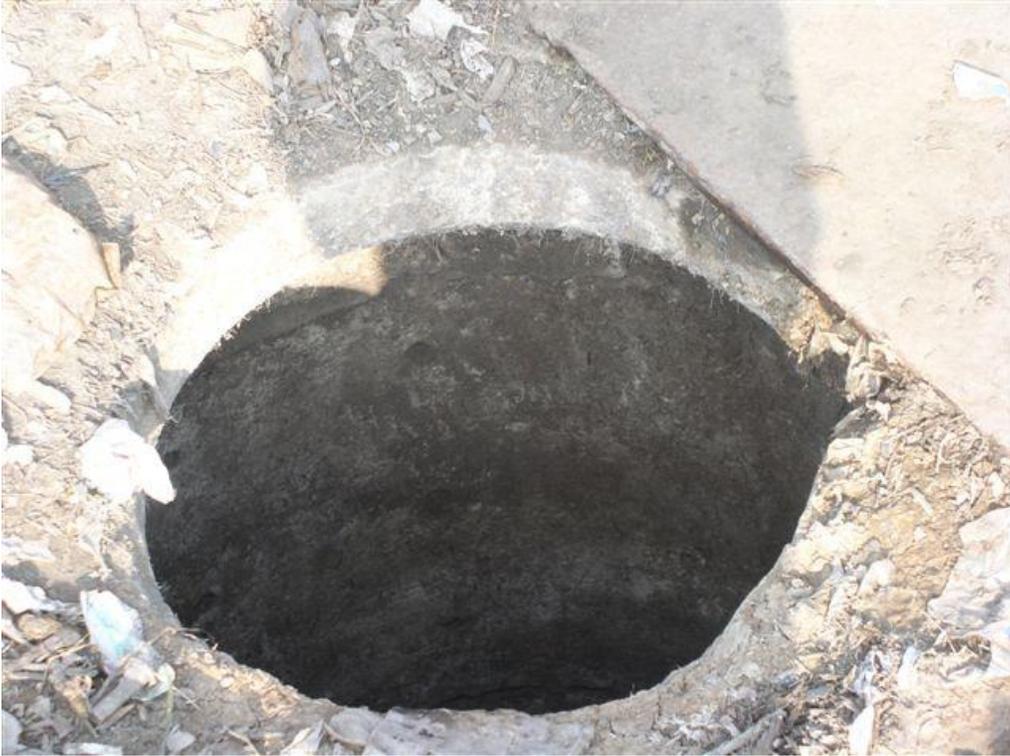
Exhibit 4. A close-up of the shaft opening.

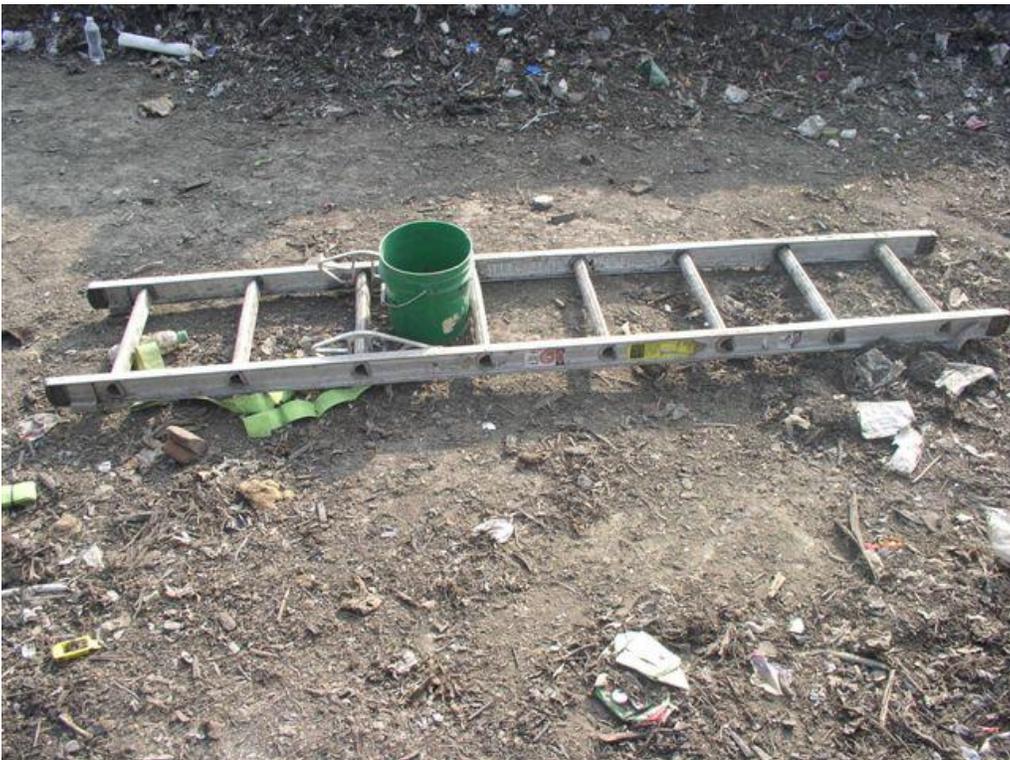
On the day of the incident, the workers were taking turns spraying water from the high pressure hose. All three took turns sitting on the edge of the shaft and directing the water stream to the bottom of the shaft. This proved unsuccessful in cleaning out the hole, so they placed an eight-foot ladder into the shaft. The 16-year-old victim was standing on the ladder inside the shaft to aim the spray of water. The 22-year-old victim witnessed his brother collapsing into the shaft, went down the ladder to rescue him, and then was overcome himself. The third employee looked down the shaft; saw both co-workers unresponsive and called for help. The fire department arrived at the incident scene and determined that hydrogen sulfide was present. The rescue team entered the shaft wearing self-contained-breathing-apparatus (SCBA) to rescue the victims. The 16-year-old was pronounced dead on arrival at the hospital, and the 22-year-old survived for two days before he was taken off life support.

Exhibit 5. The ladder found in the shaft opening.

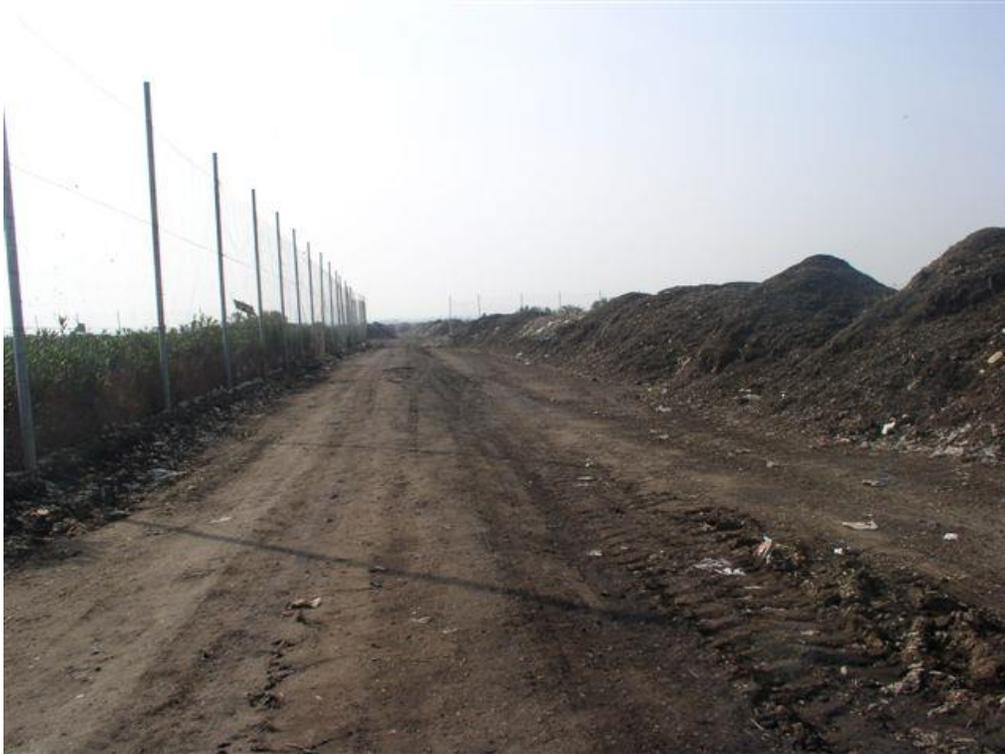
The incident occurred on a multi-acre organic waste recycling facility where organic materials from commercial and residential sites were turned into compost. Organic materials were piled into large wind rows (a long row) and treated with water and chemicals to speed biodegradation. A storm drain system below ground carried water and debris to a catch basin on the property.

Exhibit 6. The wind rows of compost at the recycling compound.
