**SUBJECT:** A machine operator died when his glove caught in a wire drawing machine.

**SUMMARY**  
**California FACE Report #02CA009**

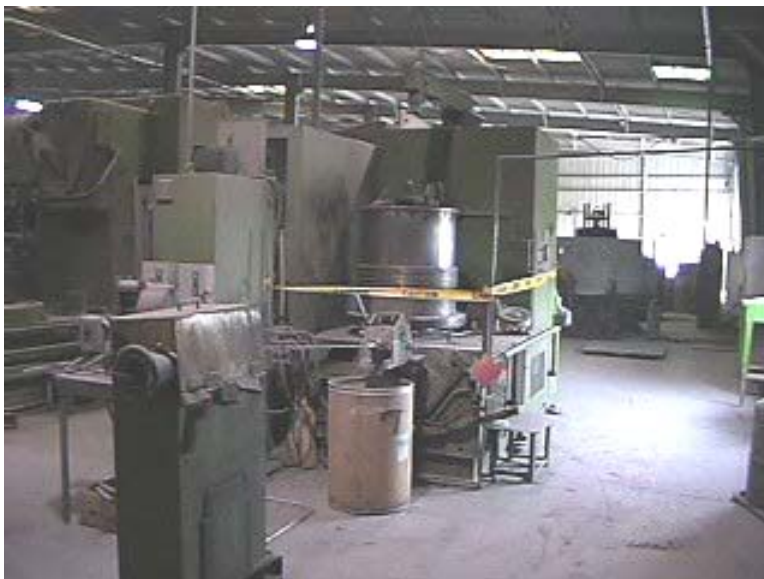
Exhibit #1

View of the wire pulling machine and reducing dies.

The site of the incident was a large industrial machine shop that spooled wire after drawing it through dies to reduce it to specific diameters. The machine used to complete this process was called a "wire drawing" or "wire pulling" machine (**exhibits #1 & 2**). The machine took larger size diameter wire and pulled it through sets of dies to reduce its diameter to a desired size. The pulling mechanism on the machine was a drum (**exhibits 3 & 4**). The operator fed the wire through the dies and a safety stop bar (**exhibit #7**), and then wrapped the wire around the drum. The drum would then rotate pulling the wire through the sets of predetermined dies (**exhibit #1**). As the drum continued to rotate, the wire was fed off the top of the drum through directional guides and into the spooling mechanism. It then spooled the finished wire onto a wire holding device (**exhibit #2**). The wire holding device was then removed from the machine and the finished product would then be stored or shipped.

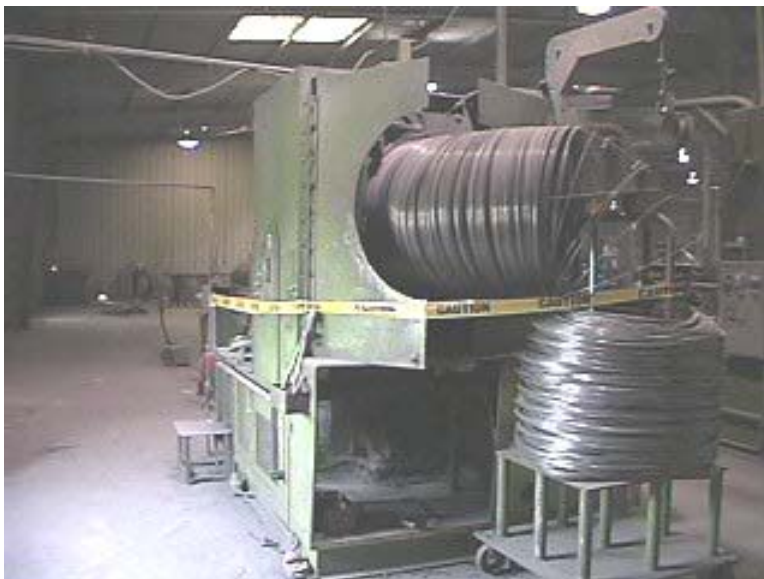
Exhibit #2

View of the wire pulling machine and the wire holding device.

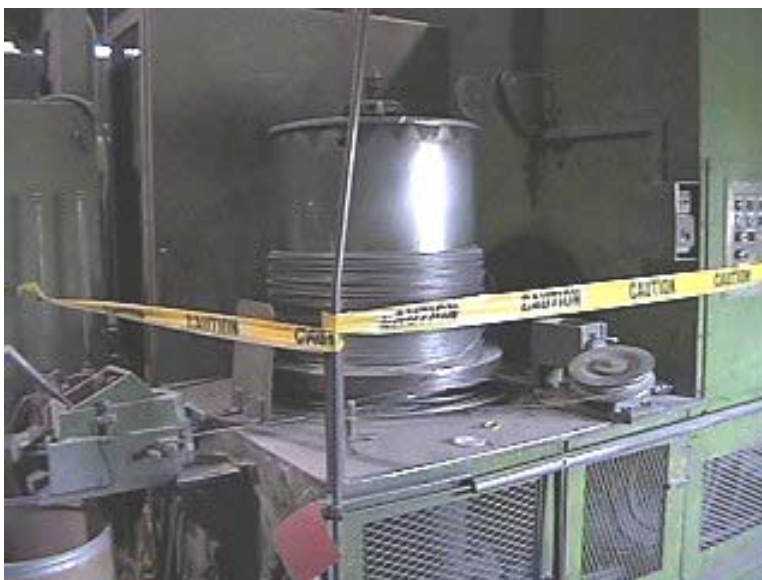
Exhibit #3

The paramedics and police arrived within minutes. CPR was administered and continued while the victim was transported to the hospital. The victim failed to regain consciousness or spontaneous respirations and was pronounced dead at the hospital. Examination of the incident site revealed that the victim reached into the area of the rotating drum and got his glove caught in the wire. This action pulled him into the machine between the drum and the machine housing.

View of the rotating drum the victim got caught in.

Discussion: Machines that have moving parts that can create a hazard for employees should be guarded. Guarding protects the employee from getting caught in moving parts and protects the machine. Had proper guards been in place on this machine, this incident might have been prevented.

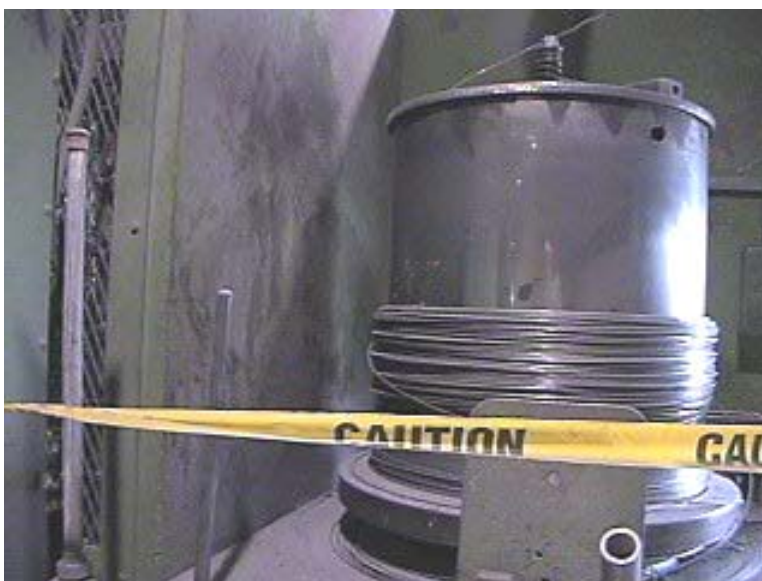
Exhibit #4

View of the rotating drum showing the area where the victim got pulled into.

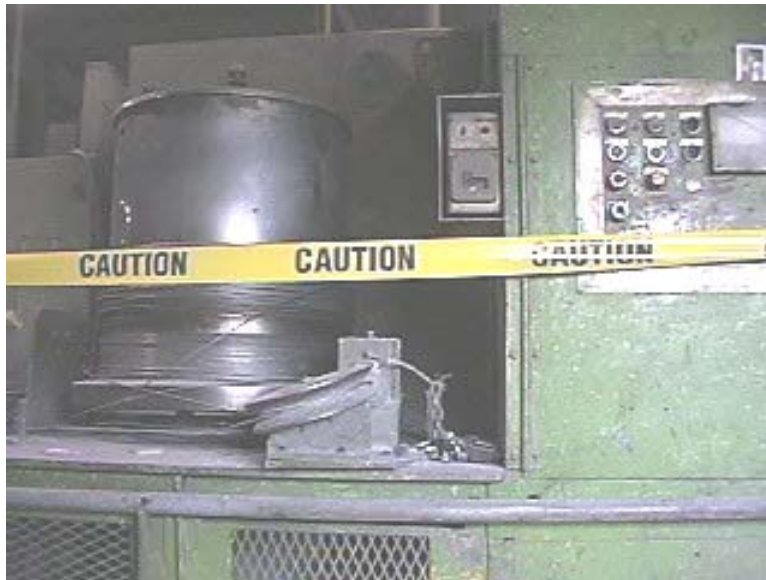
Exhibit #5

View of the rotating drum in proximity to the machine control panel.

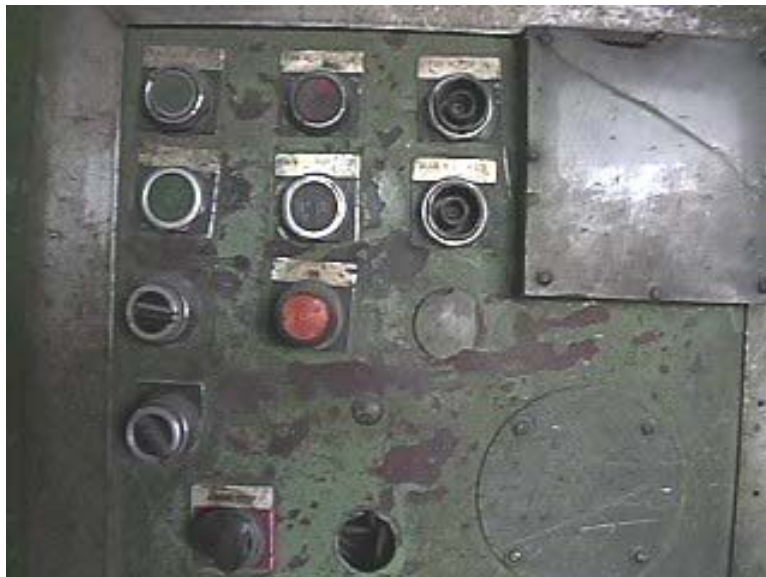
Exhibit #6

Discussion: The machine involved in this incident had a safety bar that should have automatically shut off the machine when the operator applied pressure to it. This device was non-operative and wired to the face of the machine. The control panel on this machine did not have proper identifying markings on the control buttons to designate their emergency shut off function. When controls are not properly marked the wrong button could be pushed by mistake. Improperly installed, non-functional, or mislabeled safety devices could contribute to an accident. Workers should not be allowed to operate machines that have identified hazards such as disabled and improperly labeled emergency shut off switches.

View of the machine control panel

**Recommendation #3: Ensure that all emergency shut off devices and switches on machines are properly installed, maintained in working condition, and properly labeled so the operator can identify them in an emergency.**

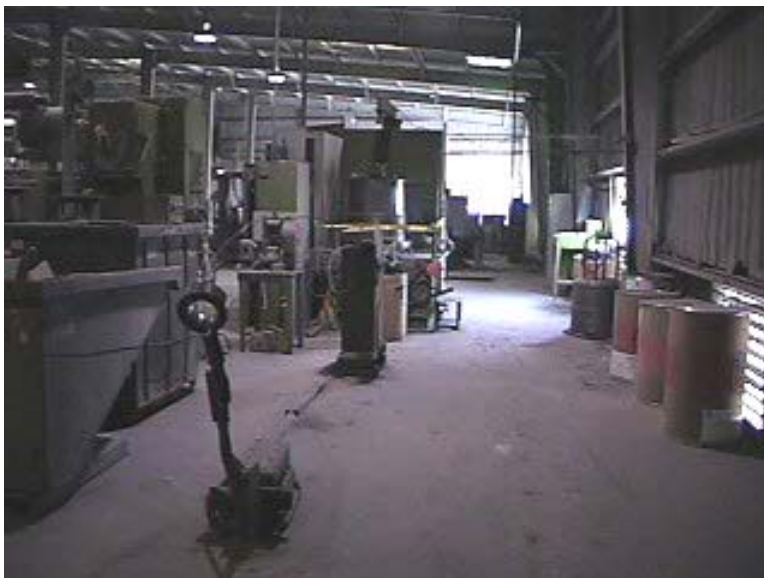
Exhibit #7

View of the safety bar the wire goes through before the dies.

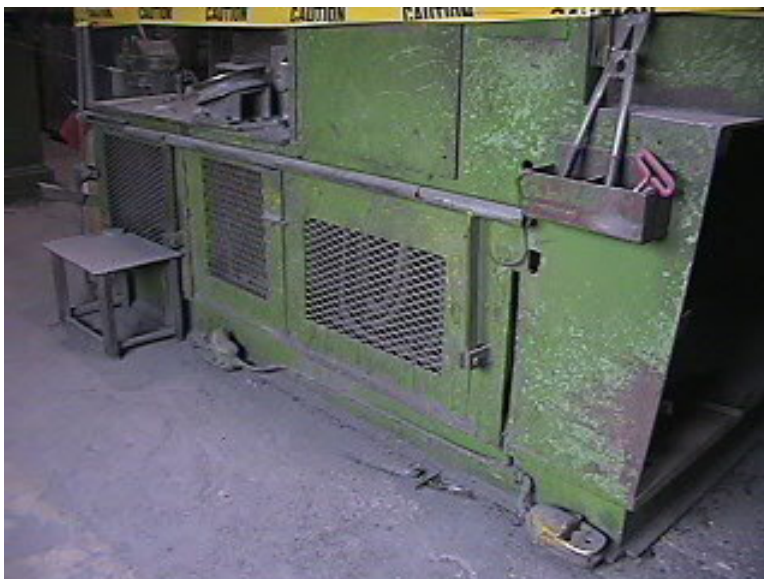
Exhibit #8

The machine had a safety stop bar hinged across the front of the machine that had been disconnected (**exhibit #8**). The bar was designed to prevent personal injury by shutting off the power to the machine when pressure was applied to it. If a worker were pulled into the machine, pressure caused by the worker's body against the safety stop bar would shut off the machine. The machine had no identifying marks to indicate its brand name, serial number or age.

View of the inoperative safety bar wired to the machine.
