**SUBJECT:** A maintenance mechanic died when the forklift he was working on slipped off a jack and fell on him.

**SUMMARY**  
**California FACE Report #03CA005**

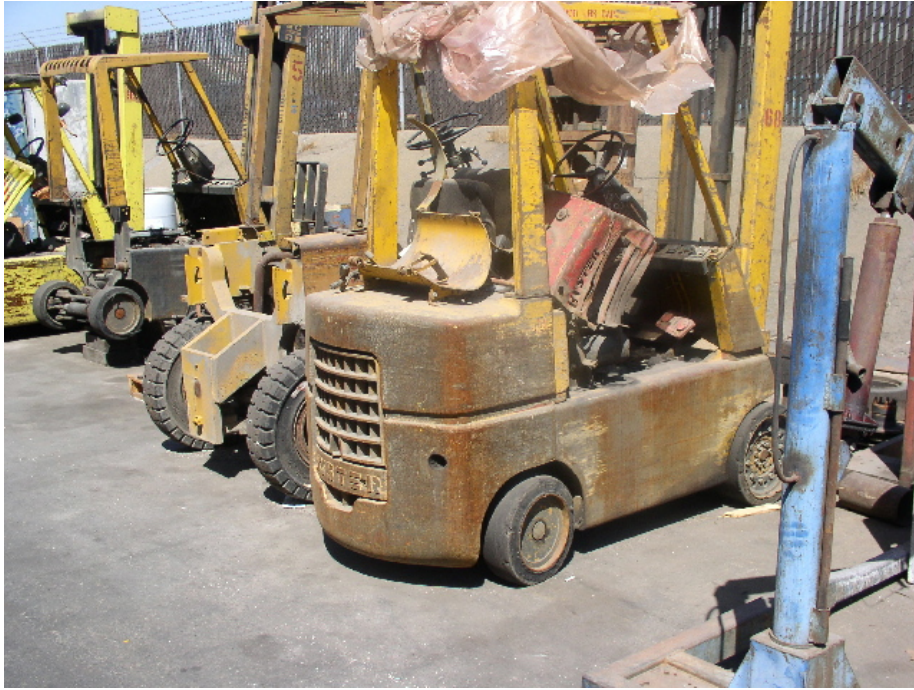
03CA005  
Exhibit #1

View of a forklift similar to the one involved in the incident.

The site of the incident was a manufacturing plant of agricultural fencing and wire products. On the day of the incident the victim was assigned to replace the starter on an industrial forklift that weighed approximately 9,000 pounds (**Exhibit #1**). The forklift was located on a slight incline in the maintenance yard outside the maintenance shop (**Exhibit #2**). The concrete ground was partially wet due to an early morning rain. The victim used a hydraulic jack rated for 8,000 lbs (**Exhibit #3**) to raise the rear of the forklift. The forks were lowered and the front wheels were on the ground so the jack did not lift the entire weight of the forklift.

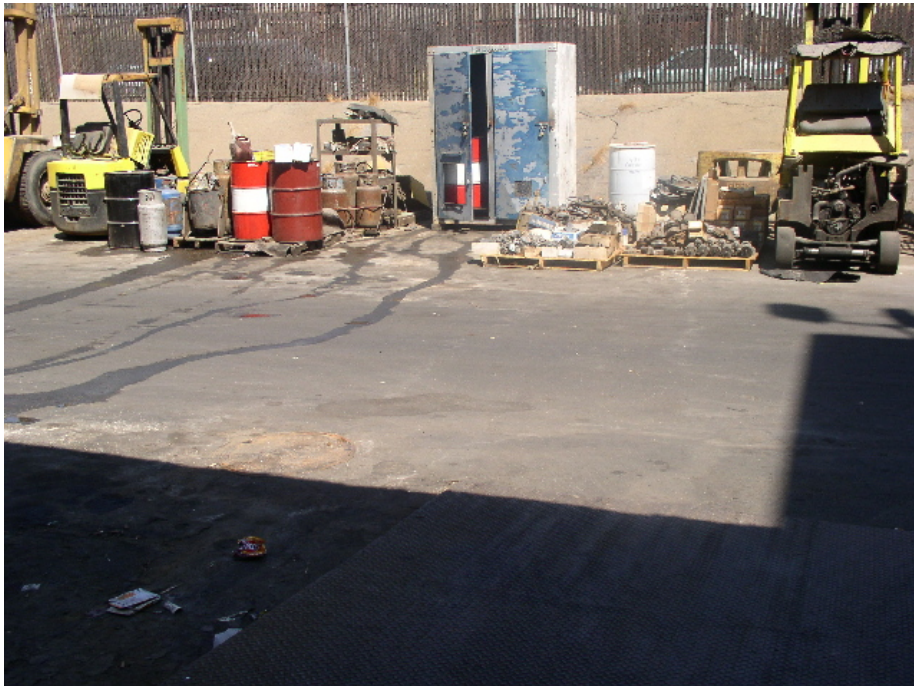
03CA005  
Exhibit #2

View of the area where in the maintenance yard where the incident took place.

### **Recommendation #2: Ensure shop floors are level and dry before elevating any equipment.**

Discussion: Most jacks are designed to lift a load while they are sitting on a dry, level surface. If the surface is not dry or level, the jack is more likely to slip or tip over. Had the victim used the jack on a level and dry surface, this incident might have been prevented.

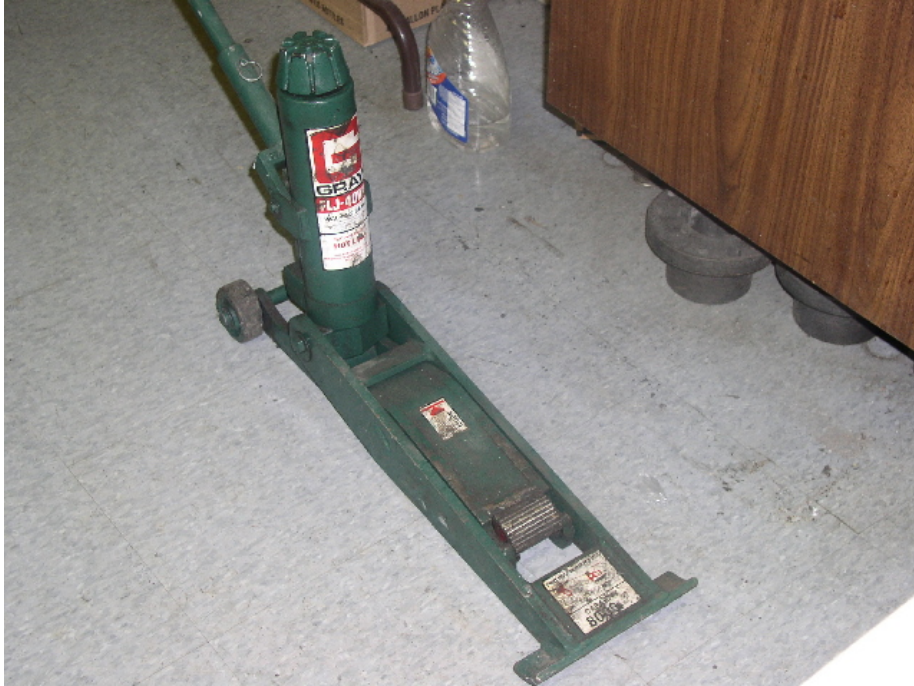
03CA005  
Exhibit #3

A picture of the jack used in this incident.

The victim was lying on his back under the left side of the forklift removing the starter. Another employee was working on another forklift about 20 feet from the victim when he heard a noise. He looked in the direction of the noise and saw the forklift on top of the victim and the jack behind the forklift in an elevated position but no longer under the forklift (**Exhibit #4**). Other employees raised the forklift and placed a metal jack stand and blocks underneath to support its weight. The paramedics were called and the victim was transported to a hospital where he was pronounced dead.

### **Recommendation #1: Ensure employees use proper jack stands, cribbing and chocking devices when working underneath elevated equipment.**

Discussion: Once a jack lifts a heavy object, the object must then be supported by either a jack stand or cribbing. Cribbing is the process whereby blocks of wood are placed under the object to support it in an elevated position. Supporting elevated objects with jack stands or cribbing ensures stability of the object especially when work has to be performed under the object. Had the decedent used proper chocking and cribbing to support the load before placing his body underneath it to do work, this incident might have been prevented.

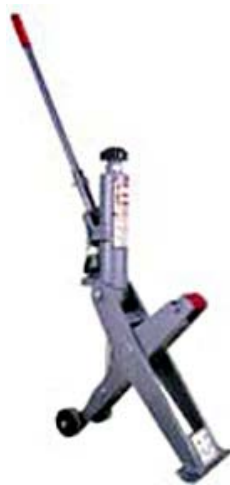
03CA005  
Exhibit #4

A picture of a jack, similar to the one involved in the incident, in the raised position
