**SUBJECT:** A youth dies when a forklift rolls over on him.

### **SUMMARY**

#### **California FACE Report # 04CA007**

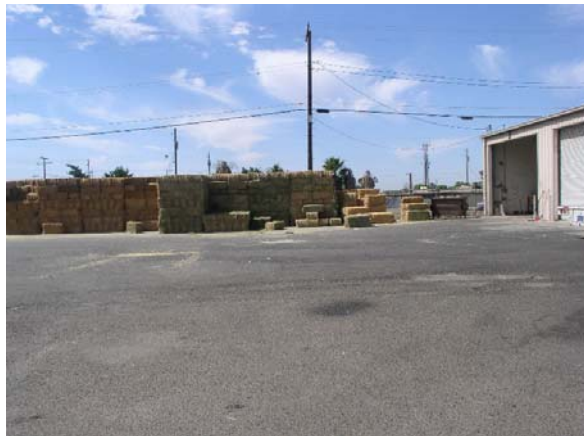
Exhibit 1. The site of the incident.

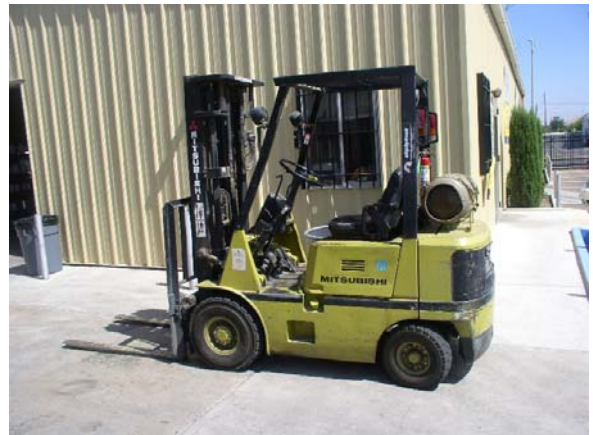
The site of the incident was a commercial grain and hay feed store with an asphalt paved yard. The machine involved in the incident was a propane-powered forklift (**Exhibit 2**). The victim's job title was a "bag hauler," and his duties consisted of placing the items a customer purchased in a bag and then carrying the bag to the customer's vehicle. The victim had graduated from high school, and was planning to work part-time, no more than three days per week, and no more than five hours per day.

Exhibit 2. The forklift involved in the incident.

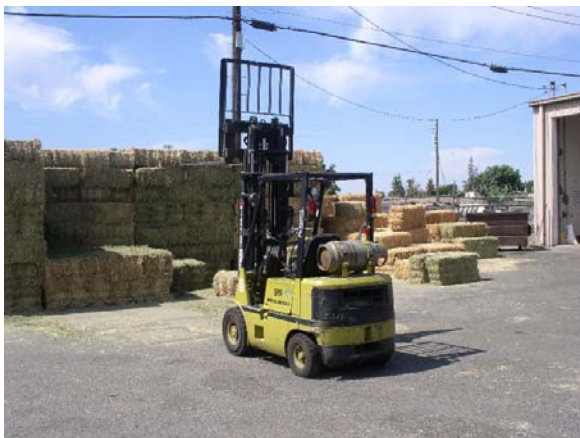
Exhibit 3. The forklift mast in the raised position.

The forklift was always parked on the side of the store with the keys in the ignition. The victim started the forklift and then drove to the other end of the yard where the hay was stacked. The hay bales were stacked seven bales high, so the victim raised the forklift mast and attempted to get the top bale. With the forklift mast raised high in the air, the victim backed the forklift over a rain gutter built into the asphalt yard. The victim lost control of the forklift and it overturned on its left side, pinning the victim as he attempted to jump free.

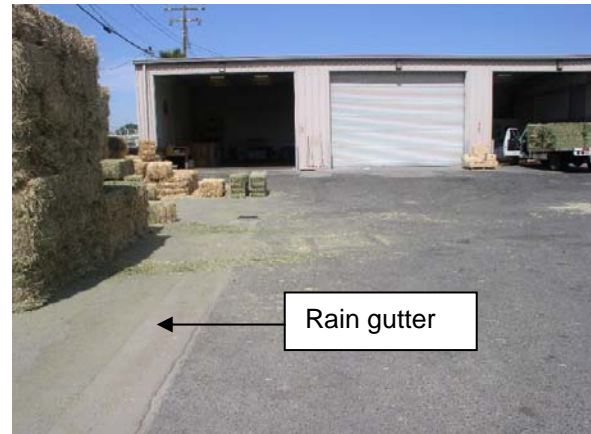
Exhibit 4. The rain gutter built into the asphalt yard.

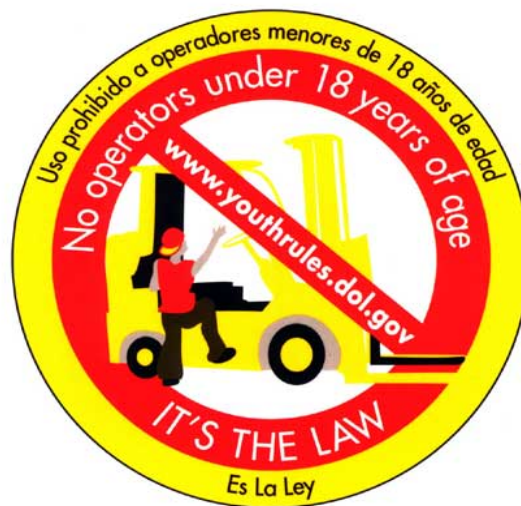
**Exhibit 5.** This sticker “NO OPERATORS UNDER 18 YEARS OF AGE. IT’S THE LAW,” is available from the local Wage and Hour office of the U.S. Department of Labor or from the DOL website <http://www.youthrules.dol.gov/posters.htm>

- **Identifying and labeling equipment that is not to be operated by workers younger than 18 years old.** Employers can obtain stickers in English and Spanish that indicate “**NO OPERATORS UNDER 18 YEARS OF AGE. IT’S THE LAW**” from the local Wage and Hour Office of the U.S. Department of Labor (DOL). These stickers can be downloaded from the Internet and should be affixed in a noticeable place on forklifts. A supervisor should be assigned to ensure, through periodic inspections, that only authorized and trained operators are operating forklifts.
