**SUBJECT:** A construction elevator operator died when he was struck by the counterweights of a construction elevator in motion

**SUMMARY**  
**California FACE Report #05CA009**

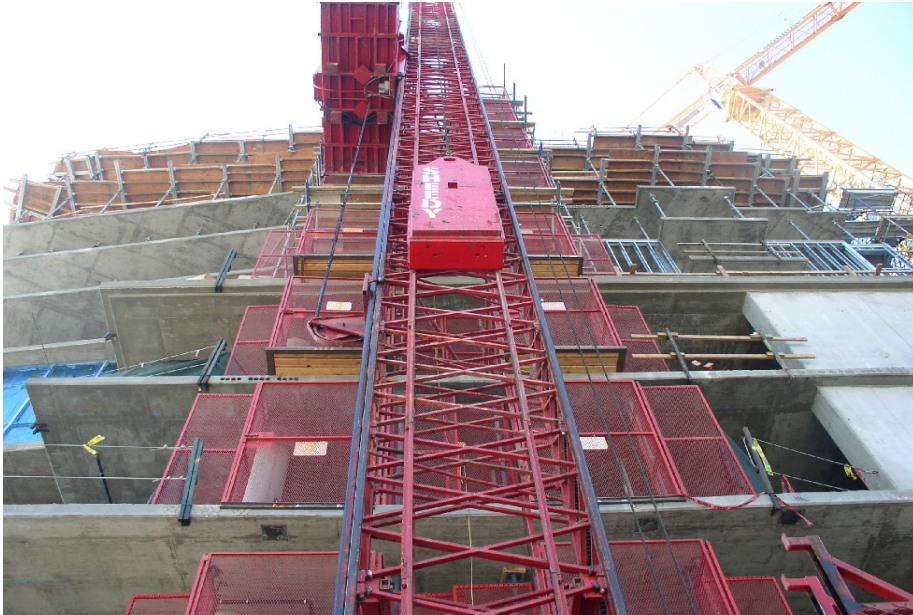
Exhibit 1. A picture of the elevator and counterweight involved in the incident.

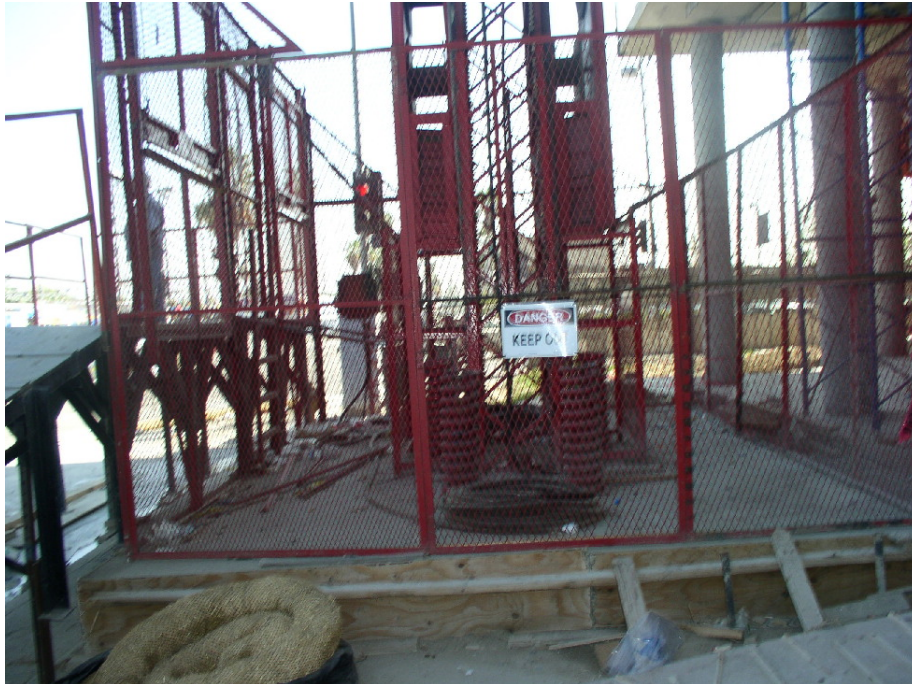
On the day of the incident, the victim reported to work at 5 a.m. He prepared the elevator for service and then transported a few workers up to their floors and noticed the elevator was not returning to a position level with the elevator landing. The victim asked a laborer to get him some tools so he could make the necessary adjustments to the elevator. This was not part of the victim's job responsibilities, and it is not known if he performed these types of adjustments to the construction elevator in the past. Without applying any lockout or tagout, the victim climbed inside the elevator mechanism and started making adjustments. While he was inside the elevator mechanism, some employees wanted to be transported up to their floor, so the victim told the laborer to take them up. The laborer did as he was instructed. As the elevator car ascended up, the counterweights descended down, striking the victim. When the laborer brought the elevator car back down to the elevator landing, he saw the victim in the elevator mechanism and called for help. The paramedics responded within minutes and found the victim in the elevator, unresponsive, with major trauma to his chest and head. He was transported to the hospital and pronounced dead by the doctor on duty.

Exhibit 2. A picture of the bottom of the elevator mechanism where the victim was found.

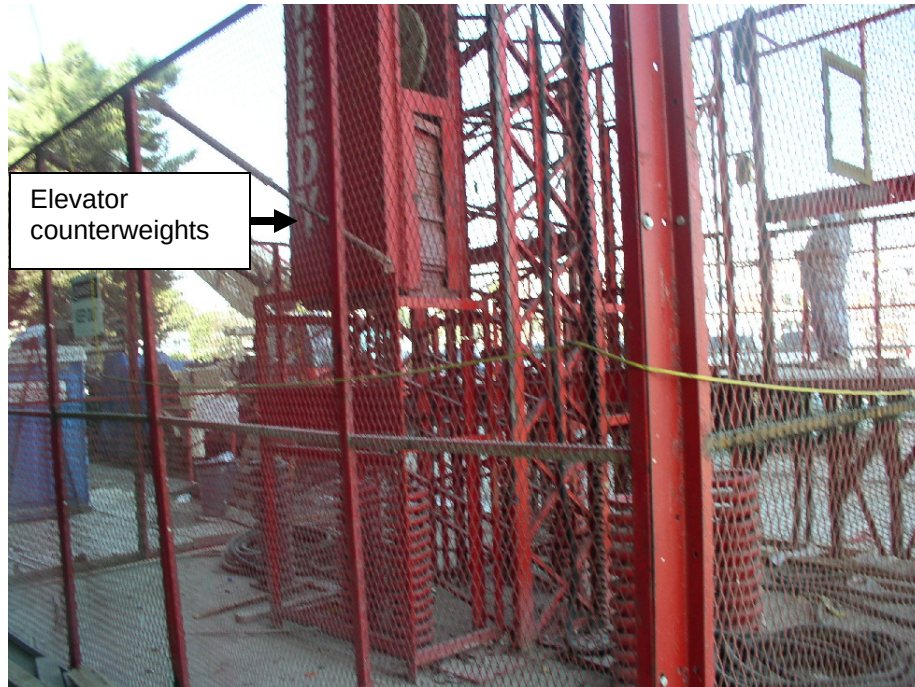
Exhibit 3. A picture of the counterweights at the bottom of the elevator mechanism when the elevator is ascended to the top floor.

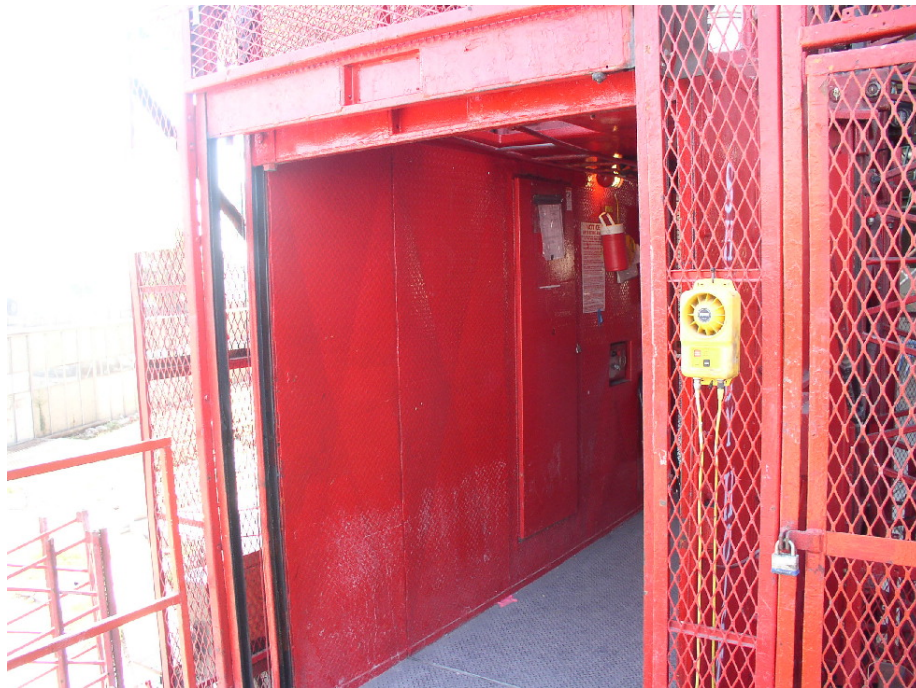
Exhibit 4. A picture of the elevator.

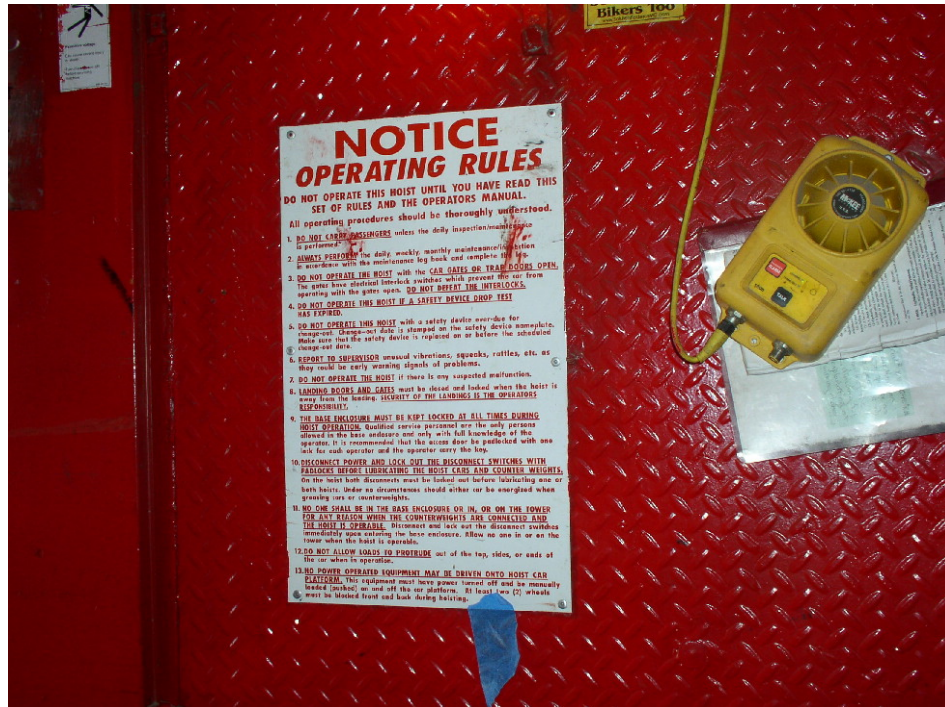
Exhibit 5. A picture of the operating rules posted inside the elevator.

Discussion: When employees report to work, supervisors have the responsibility to provide their employees with all the necessary tools to do their job safely. These tools include safe work procedures and the enforcement of those procedures. The victim was a union member who was hired out of the union hall to specifically perform the function of operating the elevator. The company who hired him gave him no instructions or orientation. The operating rules for the elevator were clearly posted inside the elevator box and stated that no one should have been within the mechanism when the elevator was running. The victim was inside the elevator mechanism making adjustments and a laborer was operating the elevator when the incident occurred. Both employees were doing something outside the scope of their work. Employers can enhance worker compliance with safe work practices through programs of task-specific training, supervision, recognition, and progressive disciplinary measures.
