SUBJECT: A machine operator's helper died when caught in a slitting machine.

SUMMARY
California FACE Report #06CA002

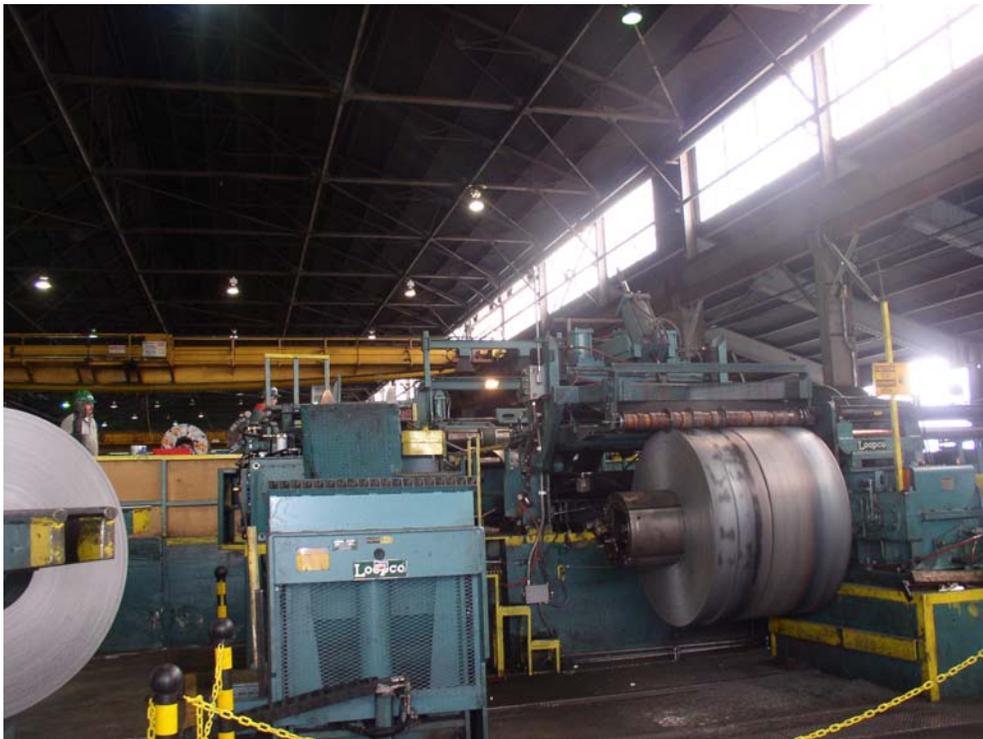
The site of the incident was a factory that manufactured carbon steel tubing. The machine involved in the incident was called a slitter. The machine was used to cut sheets of different gauges of steel into different widths depending on the customer's order. On the day of the incident the victim and another temporary employee were

Exhibit 1. A picture of the slitting machine involved in the incident.

Recommendation #1: Ensure employee safety by installing guards around the moving parts and pinch points of machinery to protect employees from accidental contact.

Discussion: In this particular case, the victim was performing a task described as one of his normal duties. Heavy machinery with rapidly moving parts can present serious risks of worker entanglement. The risk associated with operating such machinery is mitigated by physical guarding, safety interlocks and sensors, and/or the use of specially adapted long-handled tools. Manufacturers of heavy machinery can ensure newly made equipment has adequate guarding, and employers should consider retrofitting older equipment.

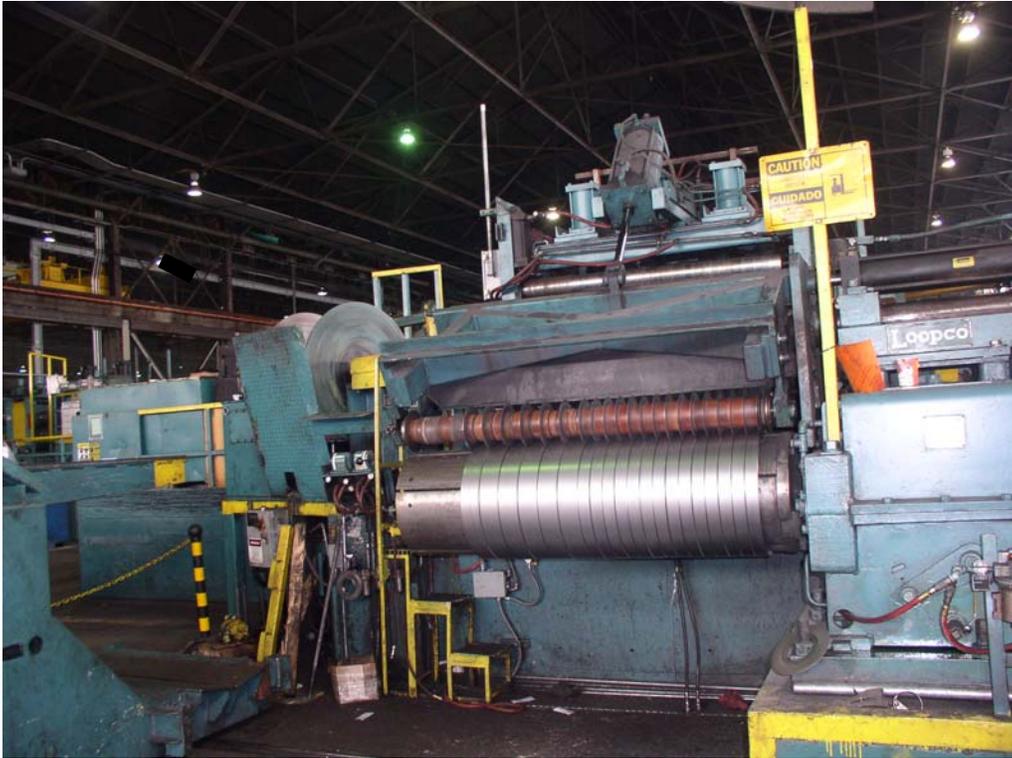
The paramedics arrived and found the victim approximately three feet off the floor entangled between the cut #16-gauge steel sheets wrapped around the rewind cylinder of the slitting machine. The paramedics found no pulse and pronounced the victim dead.

Exhibit 2. A picture of the rewind cylinder with the cut steel being wound onto the cylinder.

Discussion: The client company in this incident had performed job-specific hazard assessments sometime in the past and had identified the open rewind cylinder as a potential entanglement risk. Their IIPP had written work practices to help avoid entanglement; however, no guarding or safety interlock system had been built for the rewind cylinder. Although the machine in this incident was constructed at a time when guarding was not required, current regulations and state-of-the-art machinery designs require guarding or safety interlocks. By periodically re-performing job hazard assessments, both the acceptability of risks from certain hazards and any new solutions to hazard abatement can be reviewed.
