SUBJECT: A Maintenance Supervisor Dies When He Falls off a Ladder into a Hot Water Tank.

SUMMARY
California FACE Report #07CA005

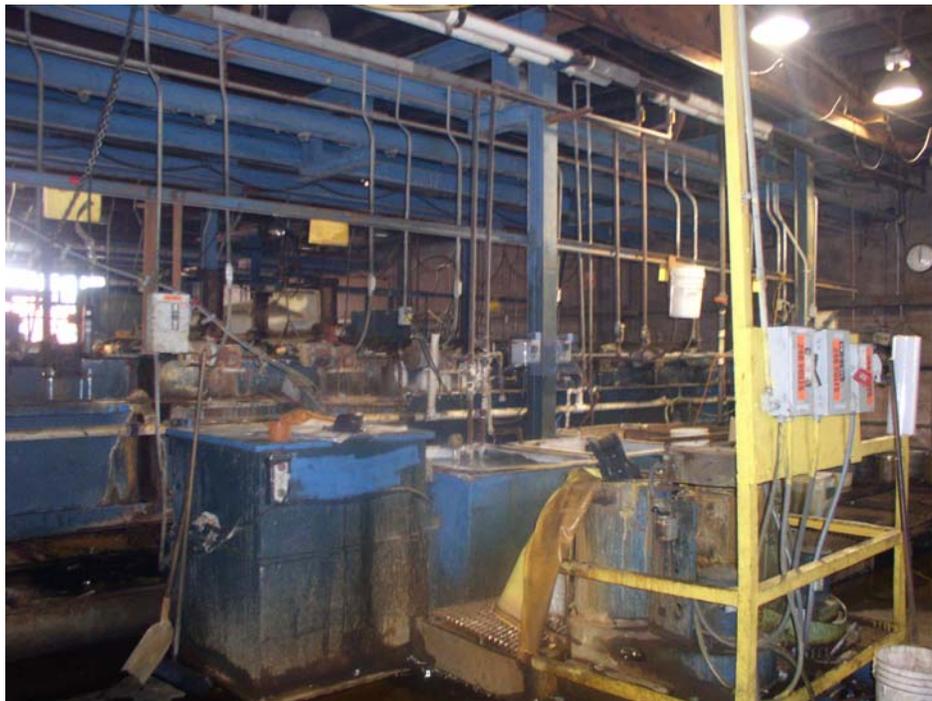
Exhibit 1. The shop where the incident took place.

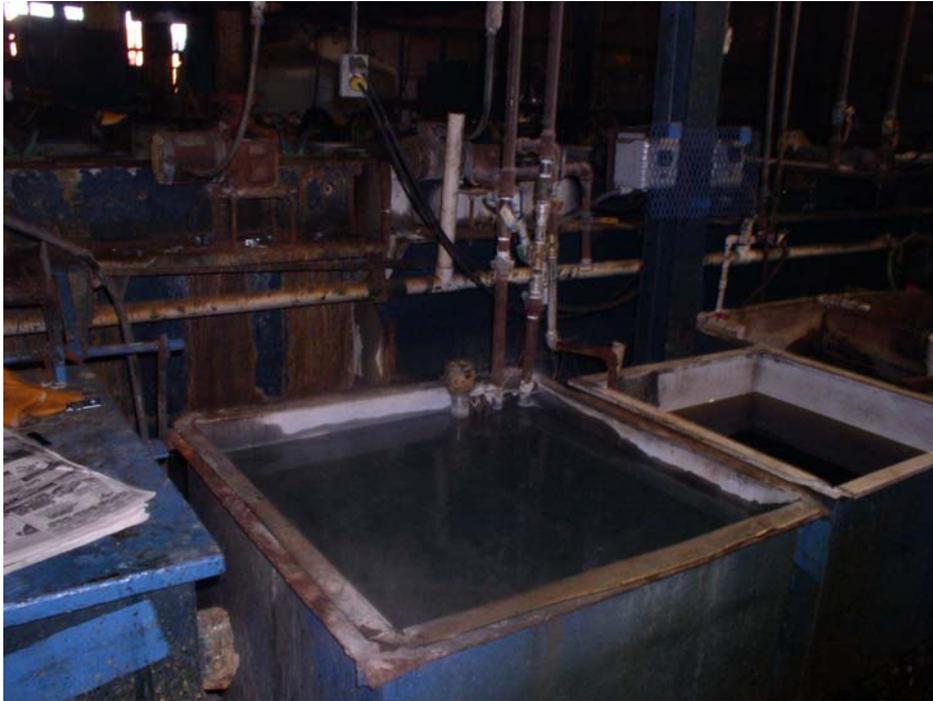
The site of the incident was the tank area of a metal finishing company. The hot water tank the victim fell into was three feet deep with a water temperature of approximately 160 degrees Fahrenheit. The tank was used for rinsing off parts that had been dipped in other chemical or acid tanks, and was not covered. On the day of the incident, the victim was responding to a service call involving a possible electrical short circuit in a dryer. With the help of an apprentice worker, the victim secured an extension ladder adjacent to the hot water tank in order to gain access to the conduit located above him. The victim used a 20-foot extension ladder with a 250-pound capacity that was manufactured in 2006. The victim ascended the ladder to the eighth or ninth rung and reached beyond the rails of the ladder to remove the cover plate on the conduit. He was about to check the wires with an electrical tester when he told the apprentice to go to the supply room for a part. It is not known if the victim slipped or received an electrical shock that may have precipitated his fall into the hot water tank. Other employees witnessed the victim exiting the tank by himself after approximately 10 seconds.

Exhibit 2. The tank filled with hot water.

Recommendation #1: Ensure vats and tanks are safeguarded by grates or covers whenever work occurs above them.

Discussion: The tank involved in this incident was not covered to prevent objects or individuals from falling into it. When employees are required to work directly above open tanks, employers should ensure that the top of the tank is covered with a grating or grille with openings no larger than two inches and of sufficient strength to hold the weight of anything that may fall on it.

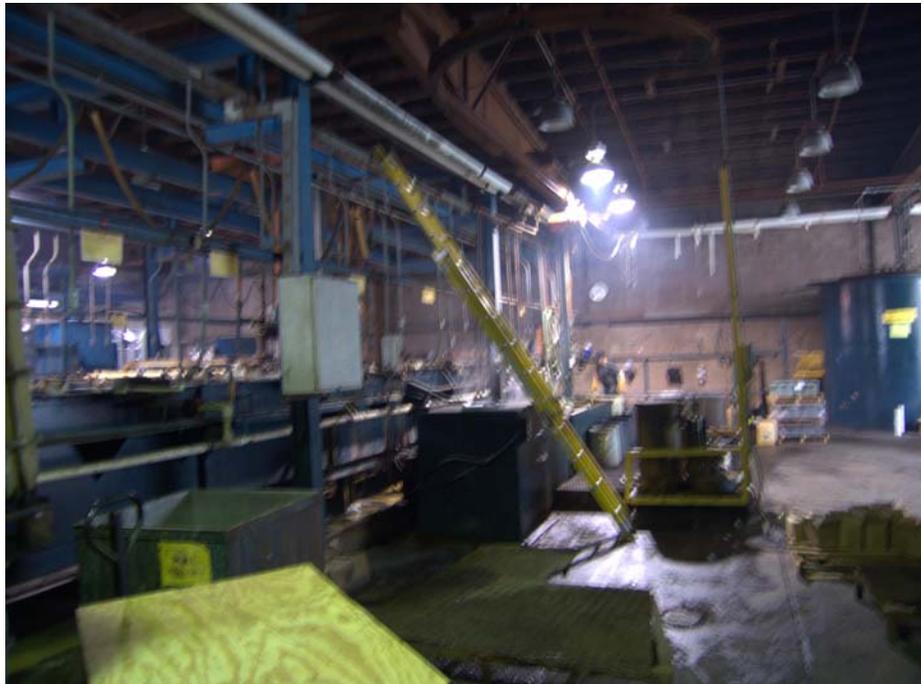
Exhibit 3. The incident scene with the ladder in place.

Discussion: The worksite should be evaluated for potential hazards prior to beginning any job or work task. Such an evaluation would have shown that a ladder was not the appropriate choice for the job. The electrical repair was located above the tank such that the use of a ladder required reaching beyond a safe distance.

Discussion: The use of a ladder limited the work area of the victim to an arm's length on each side of the ladder. In order to reach the conduit, the victim needed to maintain his balance while holding the ladder with one hand. Although the fall was not witnessed, it is likely the victim lost his balance by attempting to exceed a safe reach. The use of mobile scaffolding or another type of work platform such as a scissor lift would have provided a stable work surface and enabled the repairs to be completed safely.

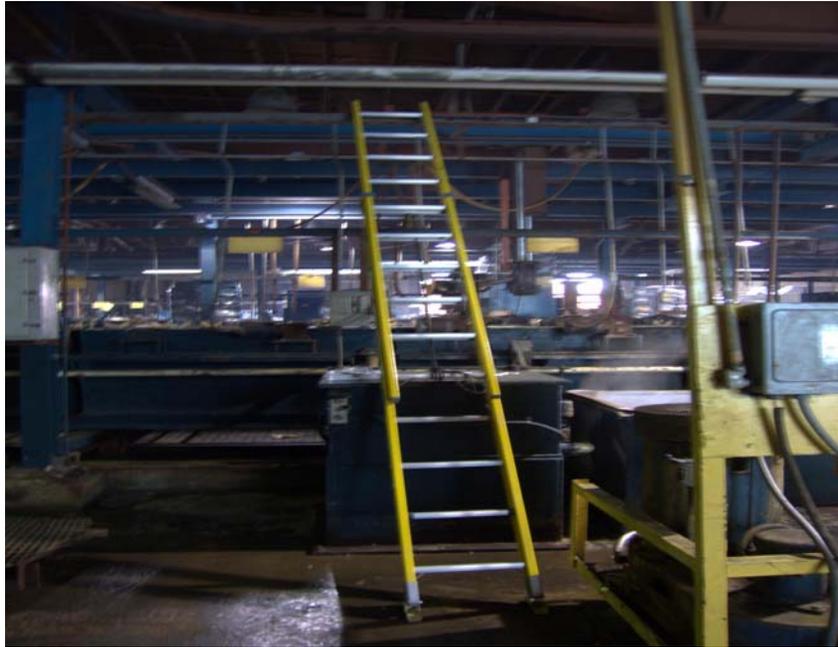
Exhibit 4. Alternate view of the ladder secured in place.

Recommendation #3: Ensure that employees use a safe method to gain access to elevated work areas.
