SUBJECT: Machine Operator Dies when a Molding Press Machine Closes on Him

SUMMARY
California FACE Report #07CA011

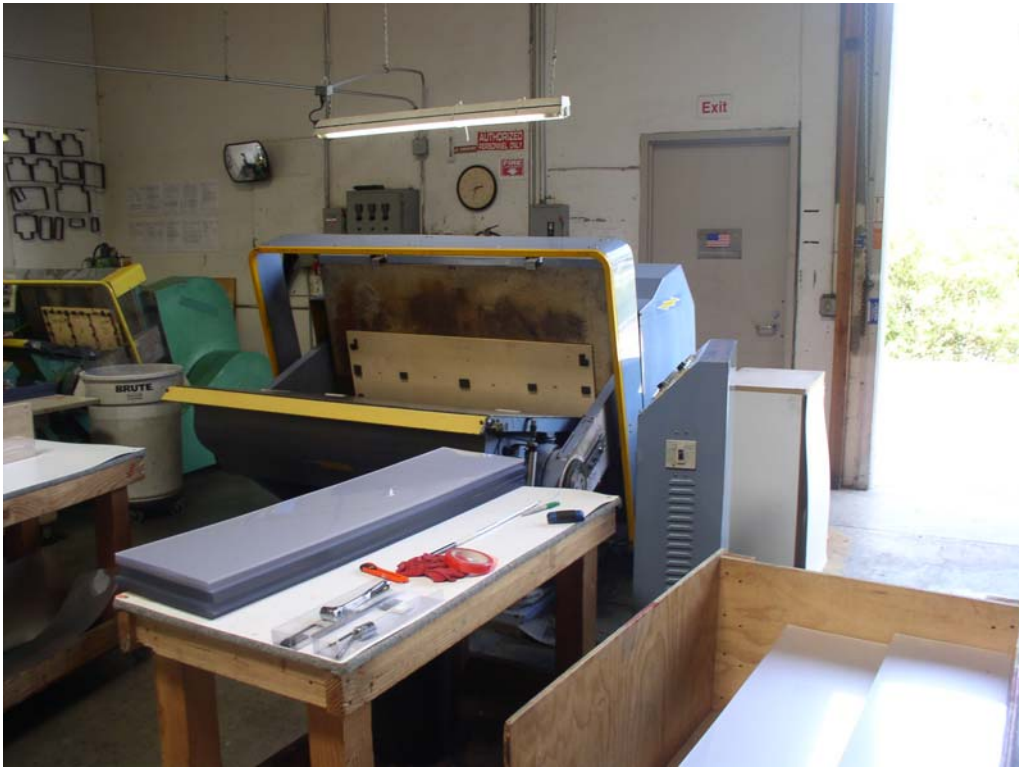
The site of the incident was a business that manufactured plastic display products. The machine involved in the incident was a creasing and cutting press machine (Zhejiang Wity Machinery Group Co., Ltd., Model ML-1400). During operation, the machine operator lays a sheet of plastic onto the flat bottom table of the machine. The bottom table automatically tilts forward and presses the plastic against the top table that contains the cutting and shaping dies.

Exhibit 1. The machine involved in the incident in the open position.

Recommendation #1: Press machine manufacturers should design presses that minimize the chances of material falling into or becoming lodged in the machine.

Discussion: When employees retrieve materials that have fallen or become lodged in areas of press machines, they may be at risk for serious injury or death from moving machine parts. In this incident, the machine had no guards or barriers to prevent material falling off the back of the table. If this creasing and cutting press had been designed with such barriers or guards, the victim would not have needed to retrieve the material.

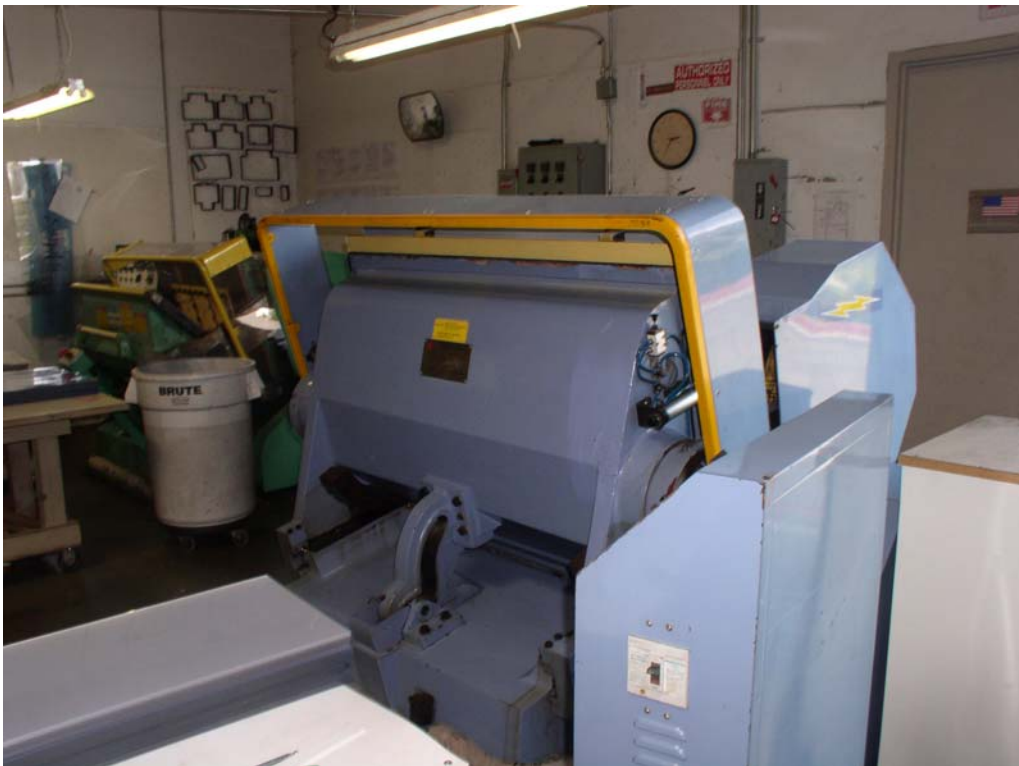
Exhibit 2. The machine involved in the incident in the closed position.

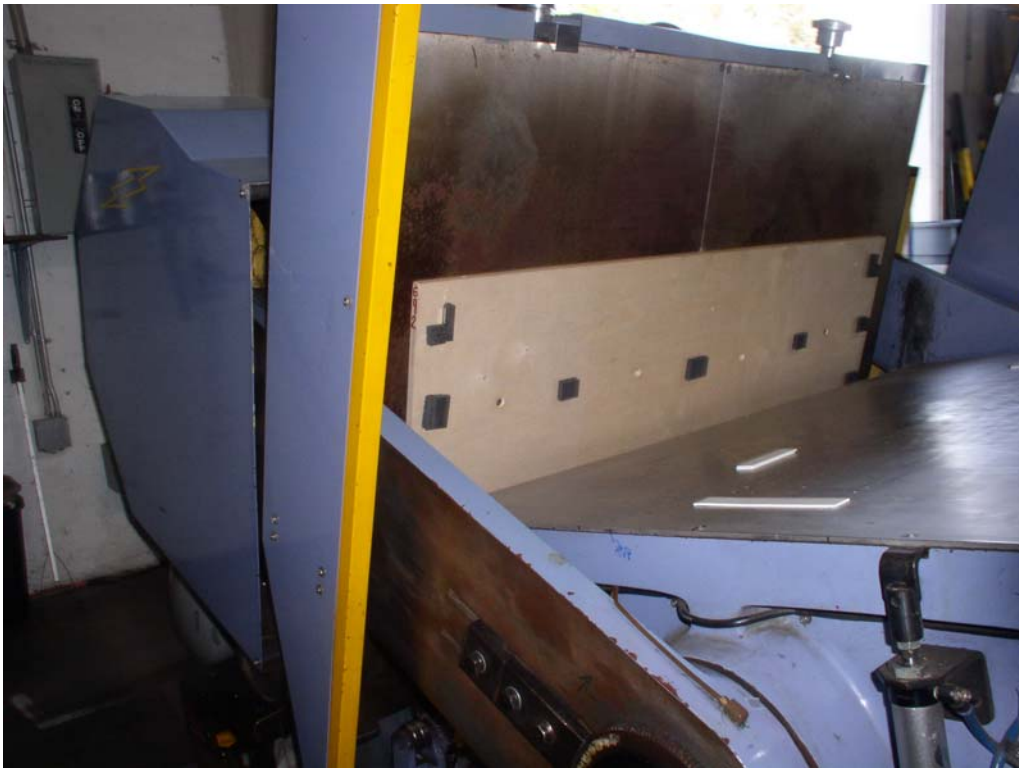
According to his supervisor, on the day of the incident the victim was installing dies. The press was powered on to test the die settings. The victim placed a sheet of plastic into the flat bottom table of the machine, and the sheet fell into the machine. As the victim reached with his hands into the machine to retrieve the plastic sheet, the machine cycled and the victim was crushed between the top and bottom tables. Coworkers were unable to extricate the victim from the machine. Emergency personnel were finally able to remove the victim after partially disassembling the machine. The victim was pronounced dead at the scene.

Exhibit 3. The area where the victim reached into the machine.

Discussion: During routine machine operations and/or setup, material may become lodged in the press. When this happens, the operator may need access to potential pinch points to retrieve the material. During this process the operator is at risk for entrapped body parts, serious injury, or death. In this case, the machine operator attempted to retrieve a piece of plastic that had fallen into the machine. If the employer in this incident had implemented safe procedures for retrieving displaced materials, the victim may not have placed himself in a pinch point of an energized machine. Examples of the types of procedures that might have been used are lock-out/tag-out or the use of a long-handled tool.

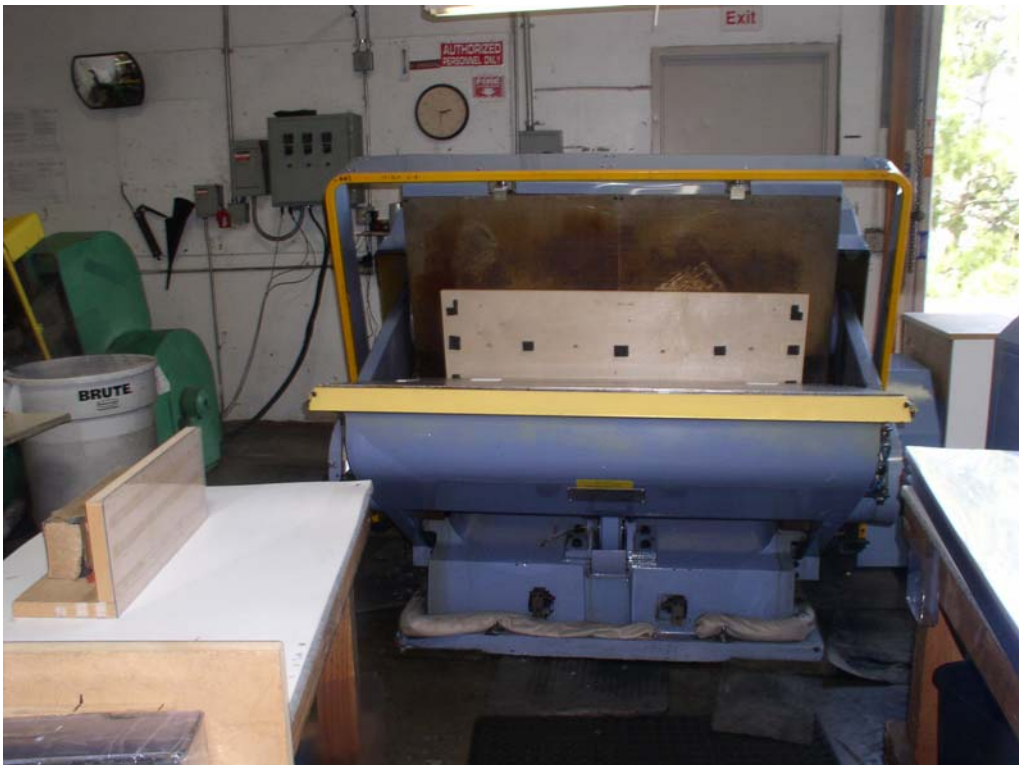
Exhibit 4. Additional view of the machine involved in the incident.
