**FATALITY ASSESSMENT AND CONTROL EVALUATION
PROGRAM (CA/FACE)**

A 16-year-old tire repair assistant died when a vehicle slipped off a hydraulic jack and fell on him while he was changing the oil
Case Report: 21CA001

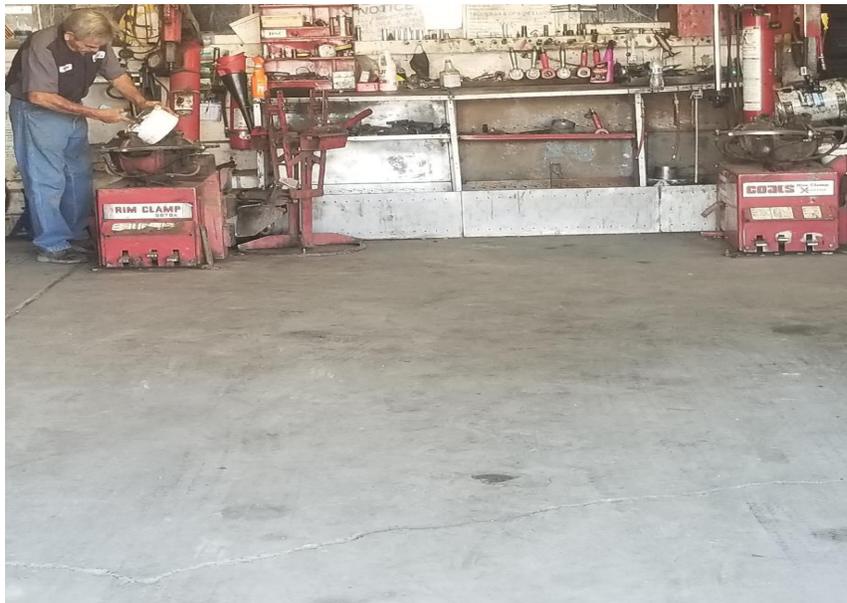
Exhibit #2. The tire shop bay where the incident occurred.

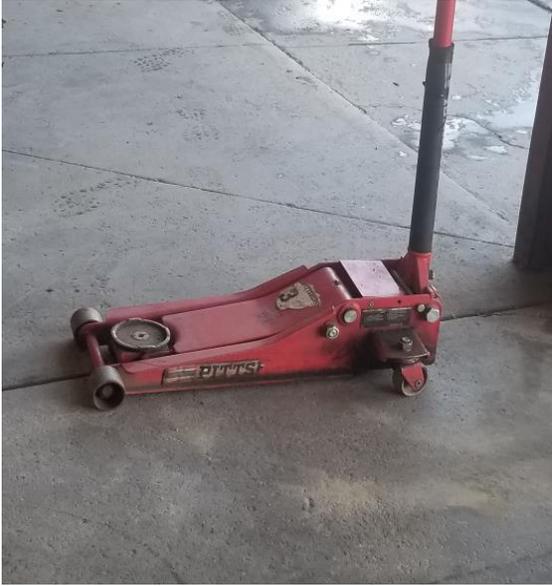
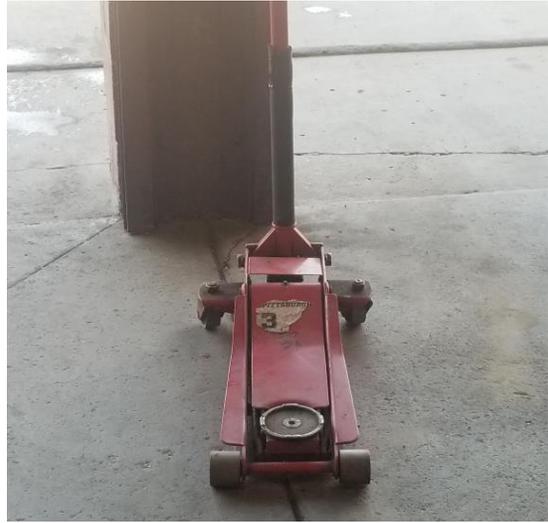
At approximately 5:30 p.m. (30 minutes before closing), a customer came in with a flat tire and the two teens agreed to change it. The vehicle was guided into the service bay and a hydraulic jack (Exhibits 3 & 4) was placed underneath the vehicle behind the left front tire. The vehicle was raised up to a height just high enough to remove the flat tire. While the vehicle was being serviced, the customer also requested an oil change. The victim placed a second hydraulic jack behind the right front tire of the vehicle and raised it off the floor. The front of the vehicle was now suspended by two hydraulic jacks. The victim then crawled underneath the vehicle to access the engine’s oil pan drain plug. The owner’s father went to the back of the shop to find a pan to contain the used oil that would be drained from the vehicle. The teen co-worker was standing in front of the raised vehicle and the vehicle owner was standing outside the shop bay. Suddenly, the hydraulic jack on the left side of the vehicle shifted, and the raised vehicle fell on the victim. The teen co-worker, using the same jack, raised the vehicle up and pulled the victim out from under the vehicle by his legs and helped him stand up for a very short time before he

Discussion: The victim was underneath a raised vehicle that was supported by two hydraulic jacks. Hydraulic jacks are lifting devices, not holding devices (such as jack stands). Hydraulic jacks alone should not be used alone when an employee needs to perform work underneath a vehicle. Cal/OSHA regulations state that employees shall not be permitted to enter the zone beneath a jack-supported load unless it has been effectively blocked or cribbed. If cribbing or jack stands had been used to support the vehicle (see Exhibit 5), the fatal collapse would not likely have occurred.

Exhibit #3 & 4. Different views of one of the two hydraulic jacks used in the incident.

Recommendation #2: Ensure that any loads raised by hydraulic jacks are supported with proper cribbing or jack stands.

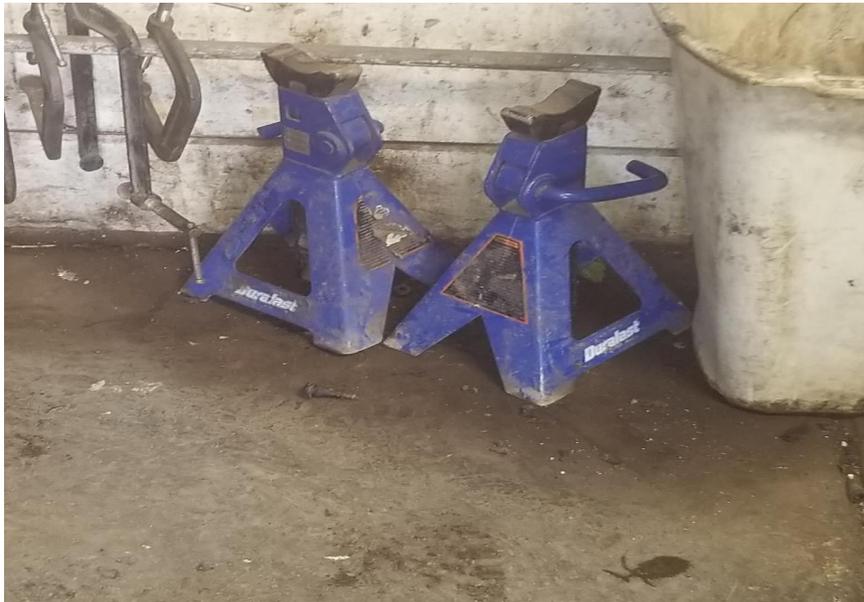
Exhibit #5. The jack stands that were available in the shop but not used on the day of the incident.
