**SUBJECT:** A maintenance mechanic died when the forklift he was working on slipped off a jack and fell on him.

**SUMMARY**  
**California FACE Report #03CA005**

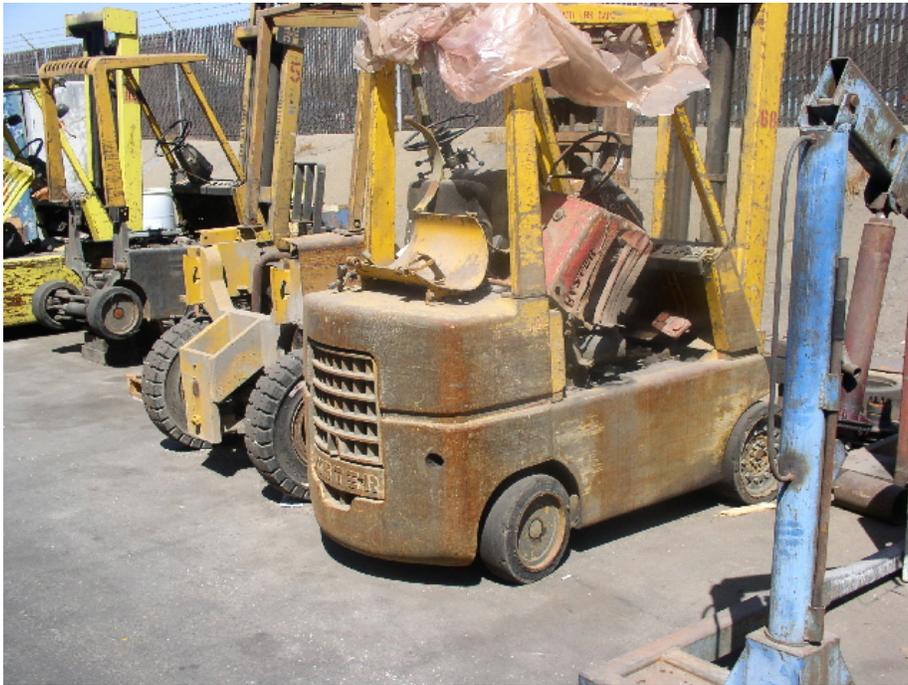
03CA005  
Exhibit #1

View of a forklift similar to the one involved in the incident.

The site of the incident was a manufacturing plant of agricultural fencing and wire products. On the day of the incident the victim was assigned to replace the starter on an industrial forklift that weighed approximately 9,000 pounds (**Exhibit #1**). The forklift was located on a slight incline in the maintenance yard outside the maintenance shop (**Exhibit #2**). The concrete ground was partially wet due to an early morning rain. The victim used a hydraulic jack rated for 8,000 lbs (**Exhibit #3**) to raise the rear of the forklift. The forks were lowered and the front wheels were on the ground so the jack did not lift the entire weight of the forklift.

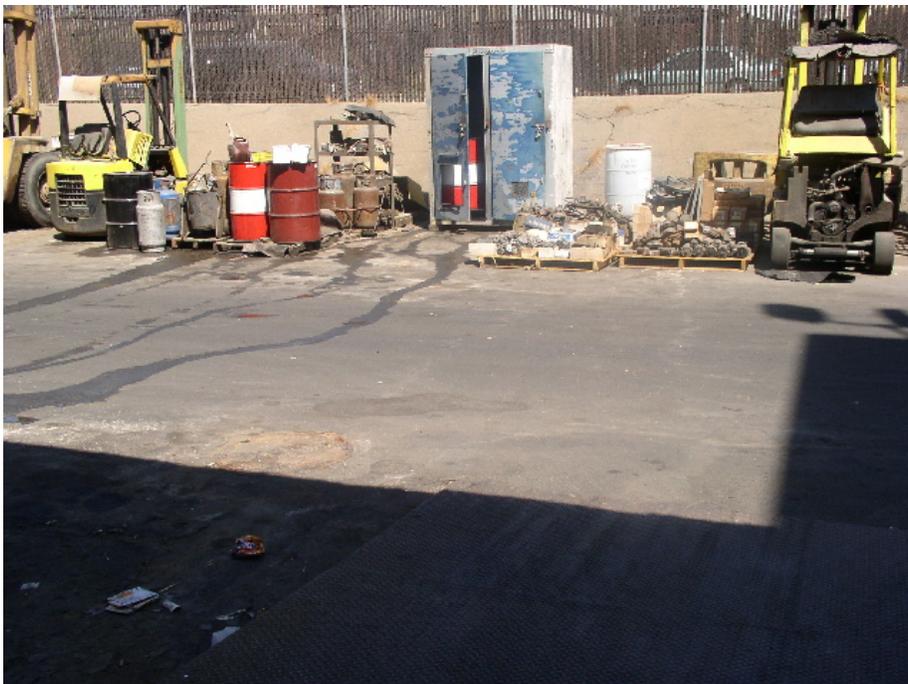
03CA005  
Exhibit #2

View of the area where in the maintenance yard where the incident took place.

Discussion: Most jacks are designed to lift a load while they are sitting on a dry, level surface. If the surface is not dry or level, the jack is more likely to slip or tip over. Had the victim used the jack on a level and dry surface, this incident might have been prevented.

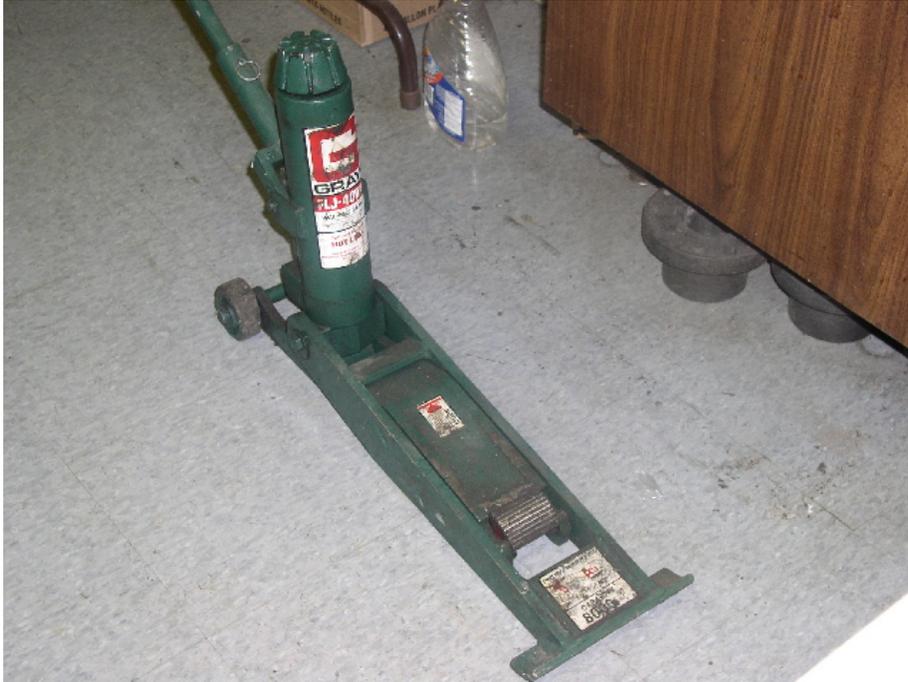
03CA005  
Exhibit #3

A picture of the jack used in this incident.

The victim was lying on his back under the left side of the forklift removing the starter. Another employee was working on another forklift about 20 feet from the victim when he heard a noise. He looked in the direction of the noise and saw the forklift on top of the victim and the jack behind the forklift in an elevated position but no longer under the forklift (**Exhibit #4**). Other employees raised the forklift and placed a metal jack stand and blocks underneath to support its weight. The paramedics were called and the victim was transported to a hospital where he was pronounced dead.

Discussion: Once a jack lifts a heavy object, the object must then be supported by either a jack stand or cribbing. Cribbing is the process whereby blocks of wood are placed under the object to support it in an elevated position. Supporting elevated objects with jack stands or cribbing ensures stability of the object especially when work has to be performed under the object. Had the decedent used proper chocking and cribbing to support the load before placing his body underneath it to do work, this incident might have been prevented.

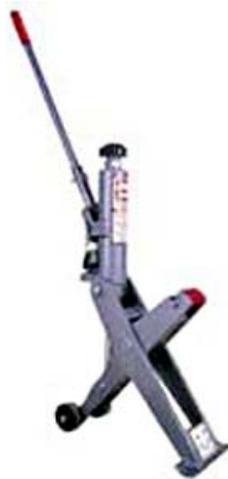
03CA005  
Exhibit #4

A picture of a jack, similar to the one involved in the incident, in the raised position
